APPENDIX B: SENSITIVITY TESTS – FLOOD IMPACT MAPPING

Title:
Bomaderry Creek Flood Study
Peak Flood Level Afflux - Roughness Scenario: 1% AEP Event

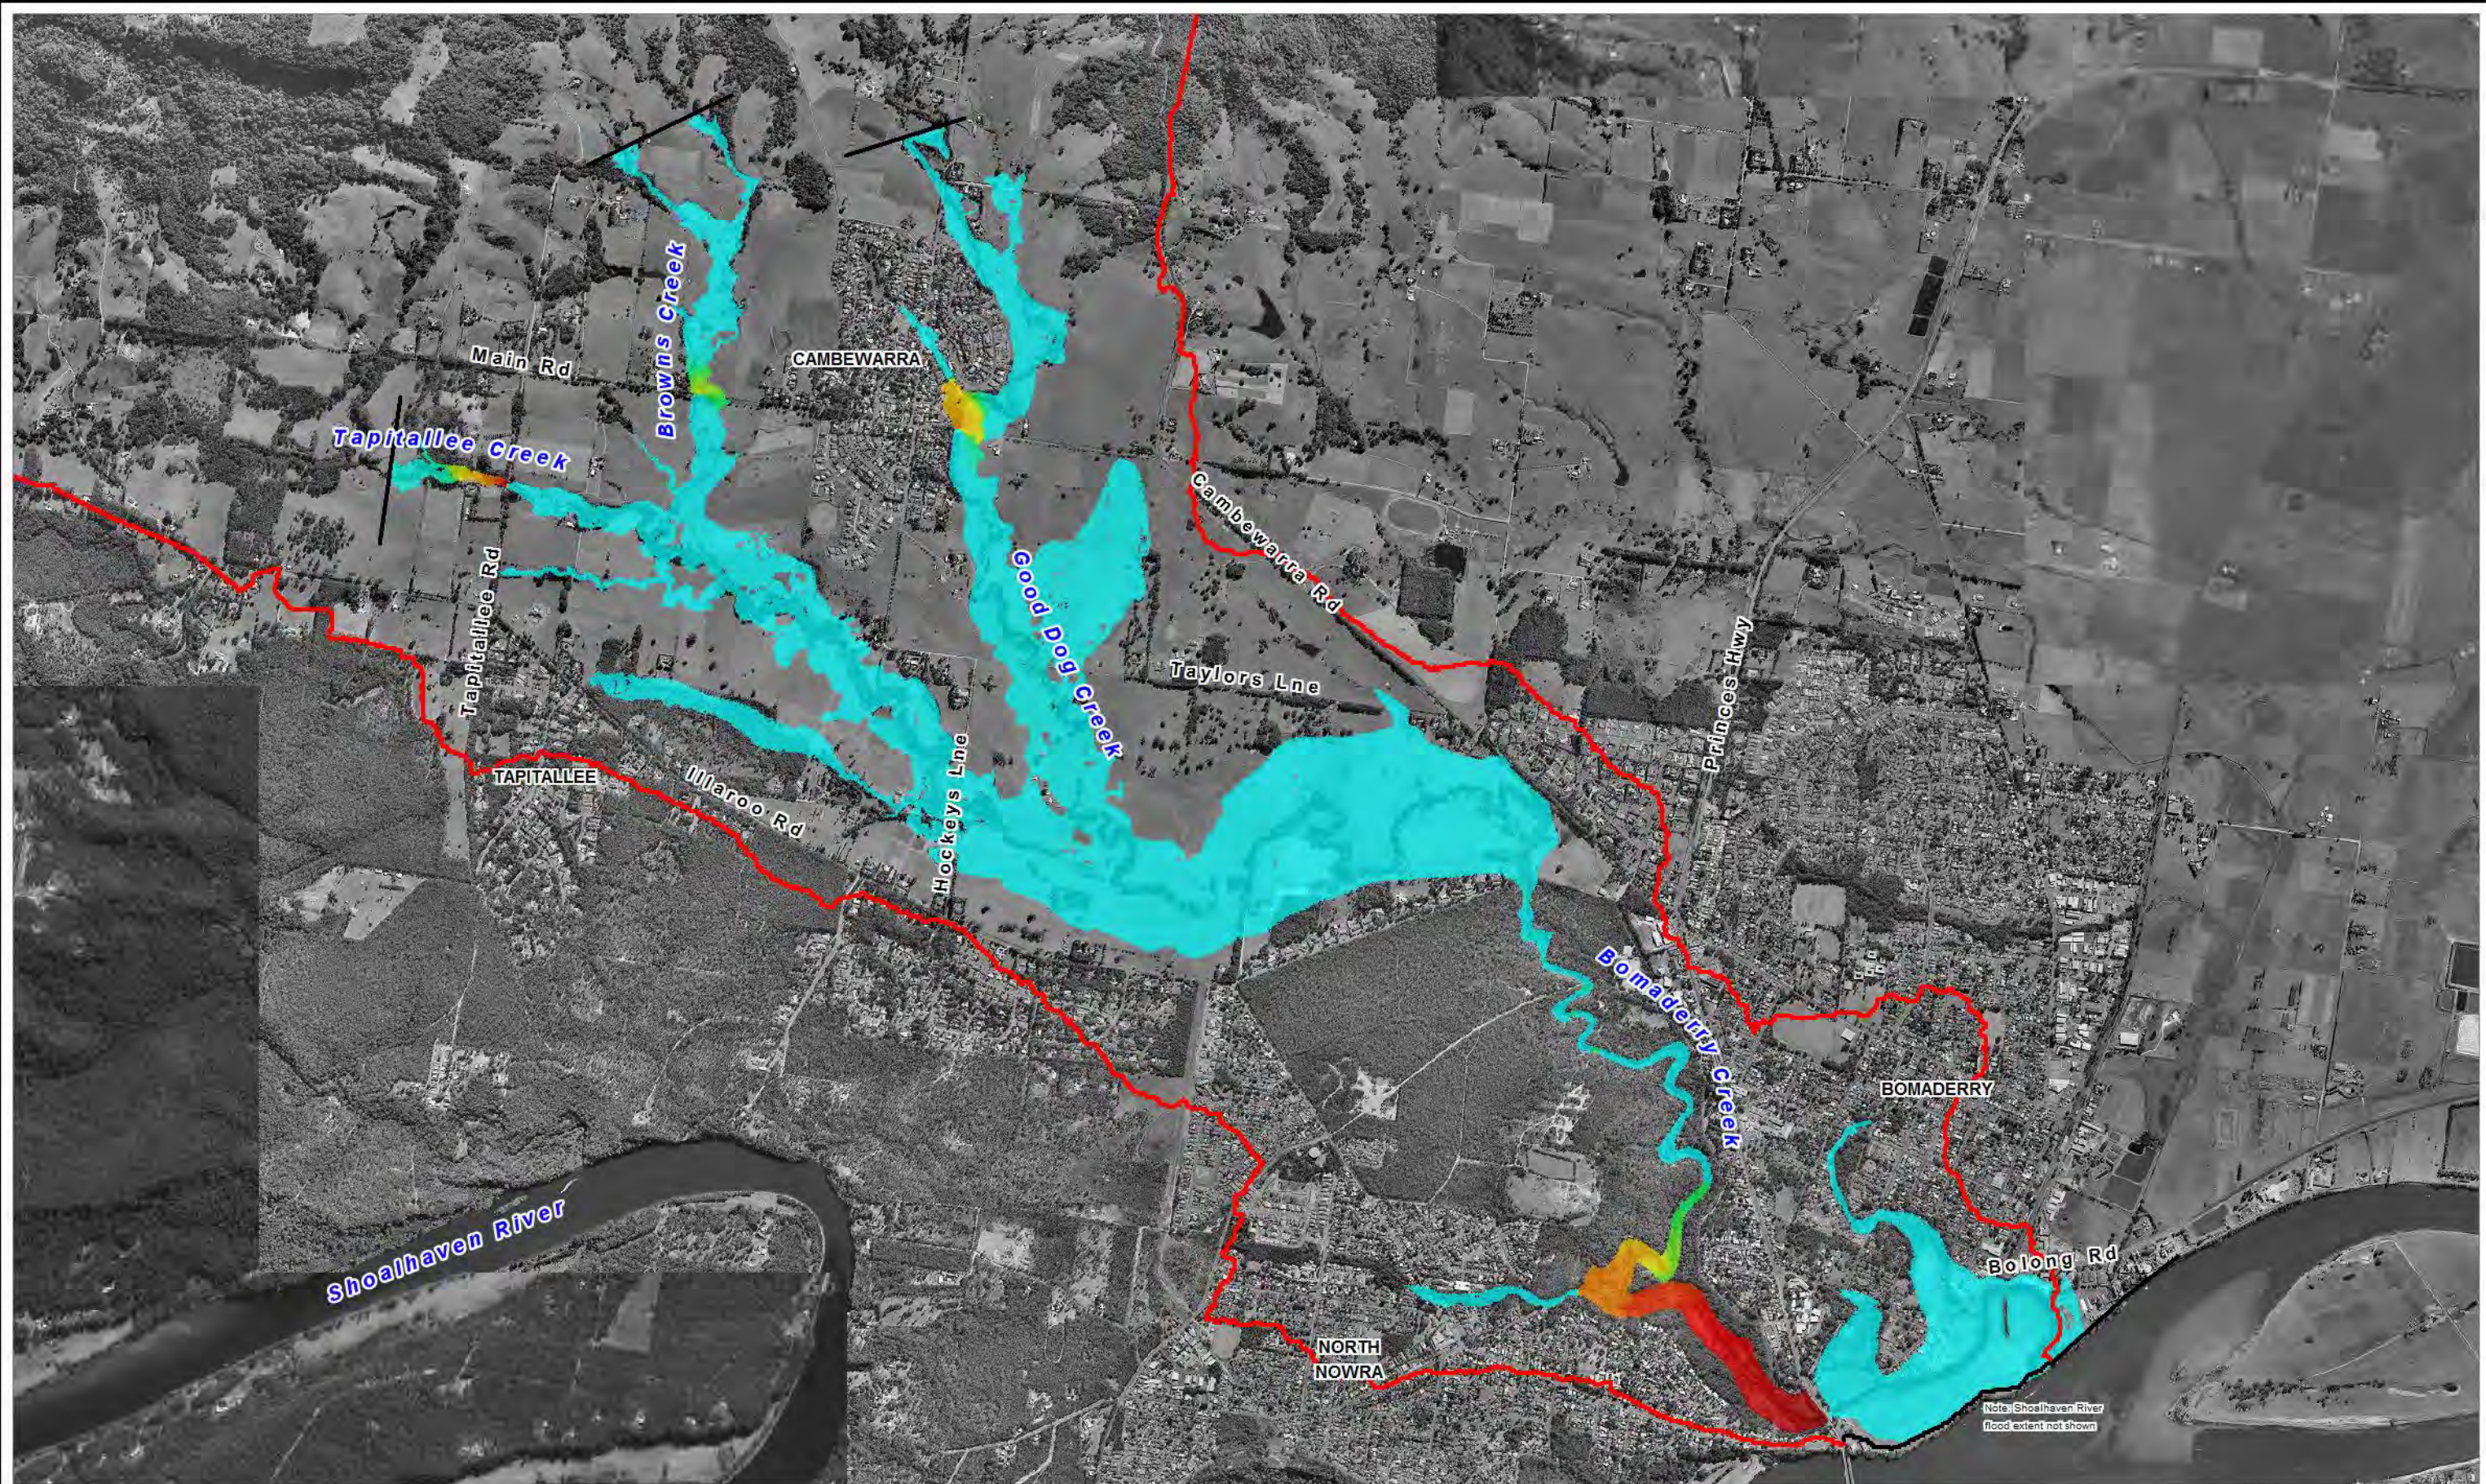
Figure:
B-2

Title:
Bomaderry Creek Flood Study
Peak Flood Level Afflux - Blockage Scenario: 1% AEP Event

Note: Shoalhaven River flood extent not shown
