# Safe Work Instruction - Installation of, Repairs and Cut-ins to Wastewater and **Water Mains**

# **Guideline for Identifying Hazardous Pipe Coatings (extracts)**

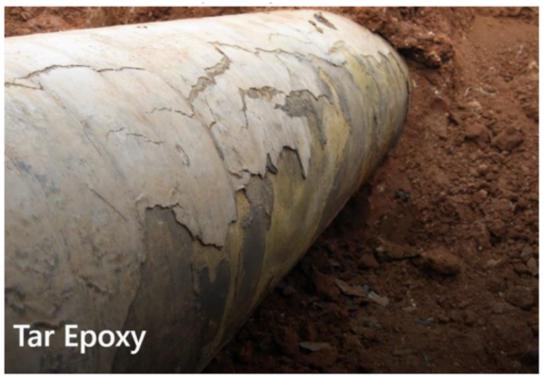
Figure 20 – Damaged asbestos coal tar coating at an unknown location. Note the remnant whitewash, spiral bandage wrap, black substrate.

- Distinctive spiral wrap Coating is formed by winding a woven asbestos bandage soaked in Coal Tar Enamel (CTE).
- Smell CTE has a distinctive smell, however, pipes installed above ground lose this smell after a few years.
- Whitewash coating new pipe was often whitewashed to reduce softening of the coating by sun exposure during transport and storage. Remnants of this whitewash can often be found, even on pipes stored in the open for decades.
- Pliant coating The coating of exhumed pipes often shows signs of deformation caused by ground stress or tree root pressure however, the coating on above-ground pipe will harden and embrittle as the volatiles evaporate.
- Weathered coating fades from black to a grey colour (in a similar way that a bitumen road fades from black to grey over time).

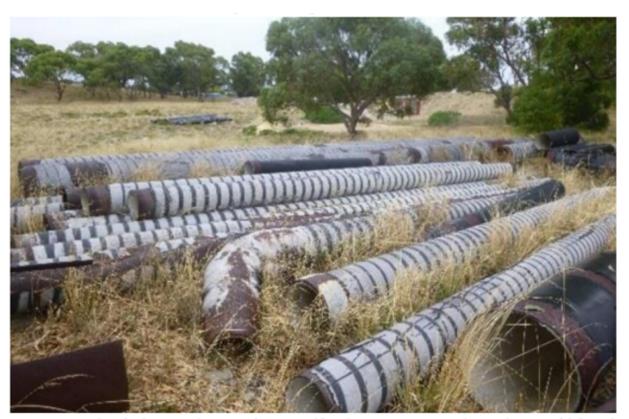
Figure 21 - Weathered asbestos coal tar coated pipe at Bold Park reservoir site. Note the spiral wrap and fading of the coating to a light grey.

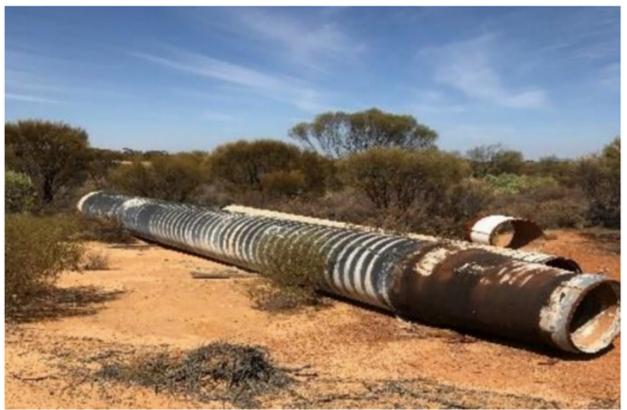
Figure 22 - Weathered asbestos coal tar coated pipe at Boondi Pump Station. Note the spiral wrap and the remnant whitewash, especially on the underside of the pipe.

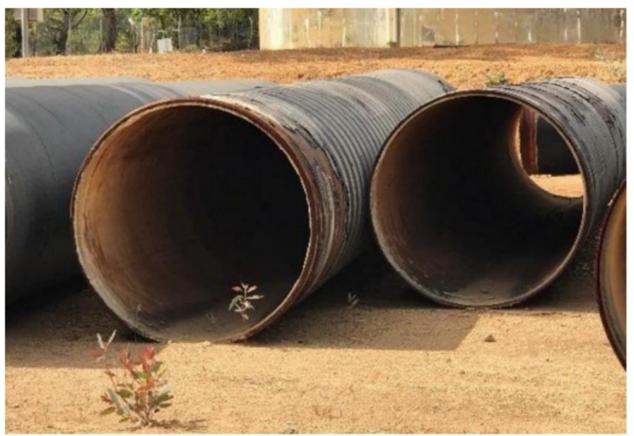
Figure 28 - Weathered asbestos coal tar coated pipe at Fleay Road, Harvey. Note the spiral wrap, remnant whitewash and coating colour weathered to light grey.
