BURRILL LAKE - INTERIM ENTRANCE MANAGEMENT POLICY

May 2008

Peter Spurway & Associates Pty Limited
495 Bingi Road
Bingi 2537

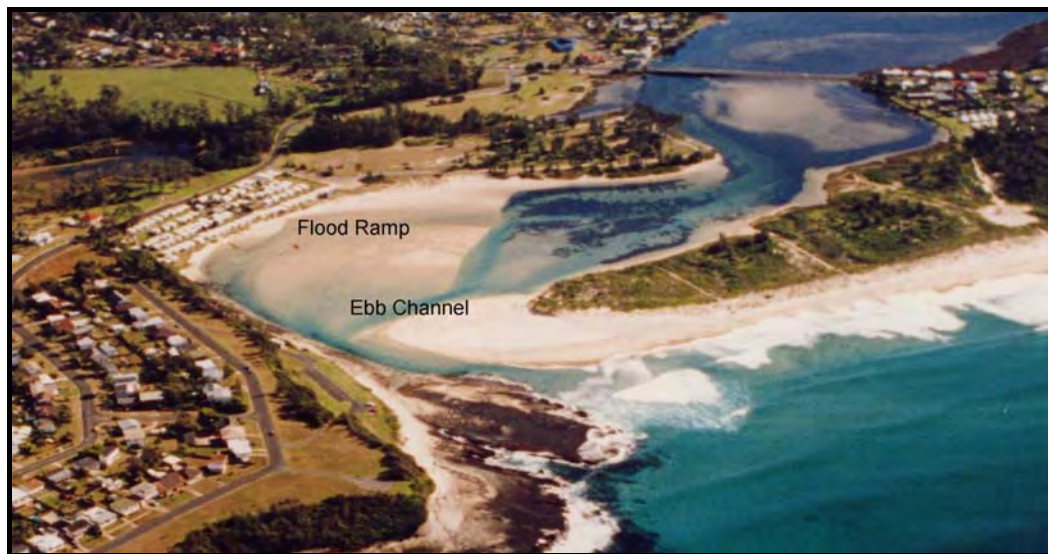
Figure 1 Typical entrance channel configuration (1993 photography)

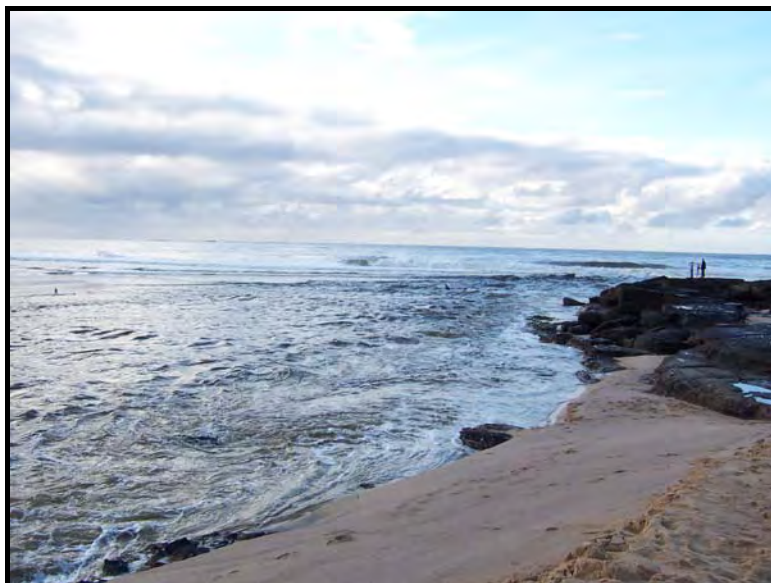
Figure 2 Entrance on the morning of 26 June 2005 following lake opening at 1.15m AHD the previous day

The entrance to Burrill Lake, which was last opened on 25th June 2005 (**Figure 2**), finally closed again on 5th August 2006. Closure followed a period of months where the berm prevented egress of lake water at low tide.

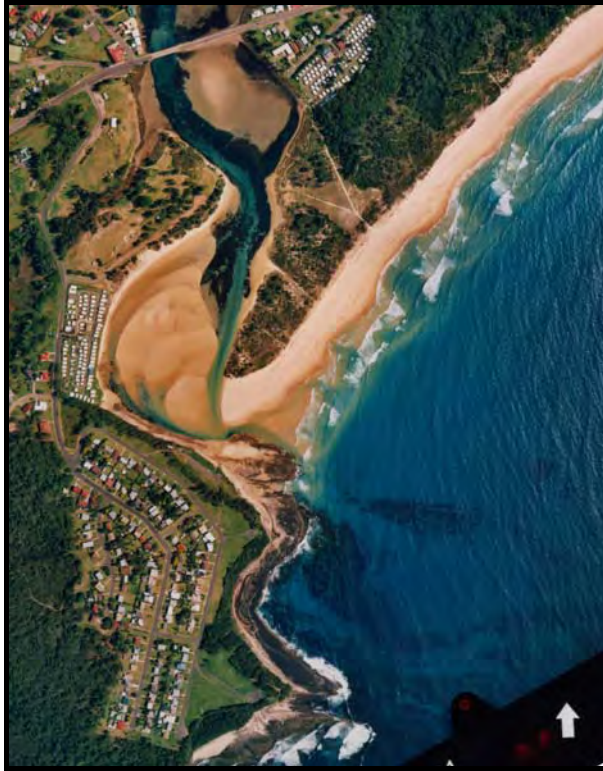
Figure 3 Entrance channel February 2001 in its most common location since aerial photograph records of the 1940s

Figures 3 and 4 show the changed shoaling pattern inside the lake mouth. The north-south ebb channel in 2001 (**Figure 3**) discharged most of the ebb tide from the lake, whereas the dead-end flood tide ramp in front of the Dolphins Point Tourist Park would have had limited ebb discharge capacity. The configuration of **Figure 3** is most common in the record of historical aerial photography (see **Appendix 1**) which dates back to the 1940s.

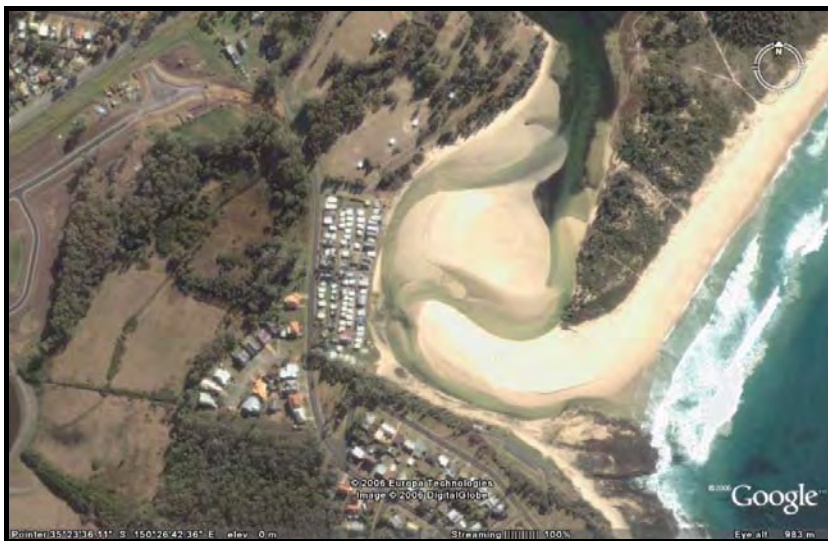
Figure 4 Early 2006 image showing westward growth of shoal and realignment / lengthening of ebb channel

The lake entrance, approaching its 2006 closure in **Figure 4**, shows clearly how the beach spit has extended westwards, extending the length of the normal ebb channel. The loss of channel conveyance limited its ability to clear sand introduced into the mouth on flood tides, leading to eventual closure.

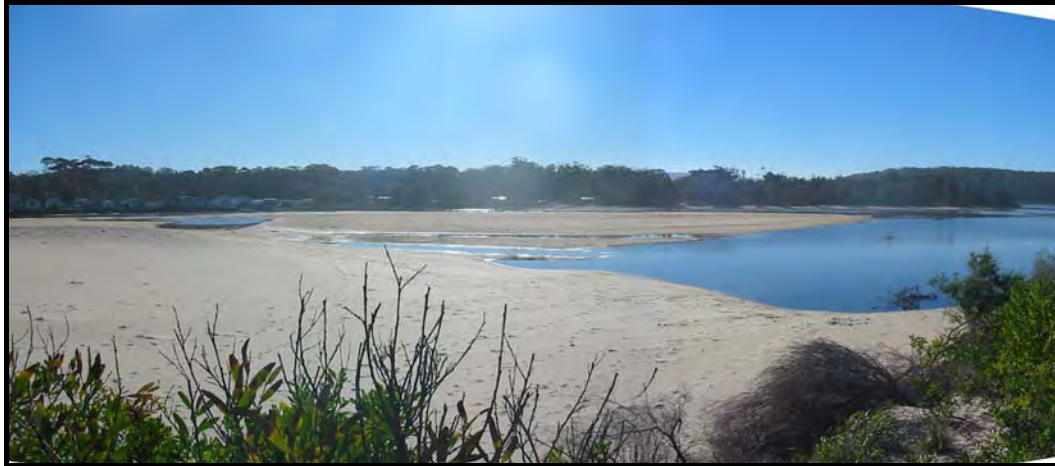
Figure 5 Blockage in north-south ebb channel (August 2006)

The main ebb channel crossing the entrance shoals was partially infilled by washover deposits a few years ago. This was worsened in March 2006 by easterly swells washing over the beach berm (*E. McLean, pers. comm.*). Washover of sand eroded from the beach face was deposited into the remnant north-south ebb channel (**Figure 5**) completely blocking the normal ebb tidal flow route.

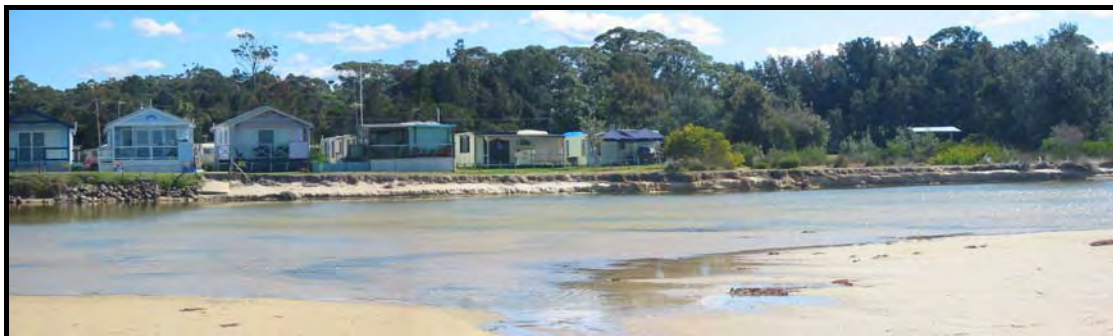
Figure 6 Dolphin Point Tourist Park showing ebb channel scour at waterline along the upstream reserve

This had resulted in a weakened tidal flow diverted to a shallow ebb channel running directly along the Dolphins Point Tourist Park embankment. Some resultant scour at the waterline at the western end of the Dolphins Point Tourist Park, and further west along the reserve, is evident. This is most likely a result of it performing as an ebb channel (**Figure 6**). The major erosion face on the unprotected embankment is most likely the result of storm wave attack and not from ebb tidal currents.

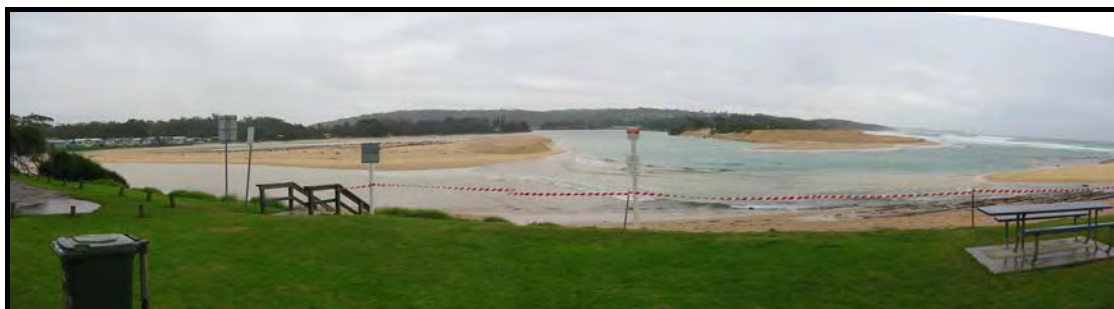
Figure 7 View upstream showing wide ebb channel two days after 17 June 2007 opening

The June 2007 opening displayed an interesting comparison between the lower opening in March 2007 at 0.99m AHD. The increased flow energy available at the higher lake level intensified the removal of sand. It mobilised and removed a large volume of sand from the beach spit and the entrance area (see **Figure 7**). Site inspection suggests large volumes of sand were deposited into the southern flood tide channel, reducing the ebb flow along the caravan park. Ebb flows in the main ebb channel was subsequently significantly increased.

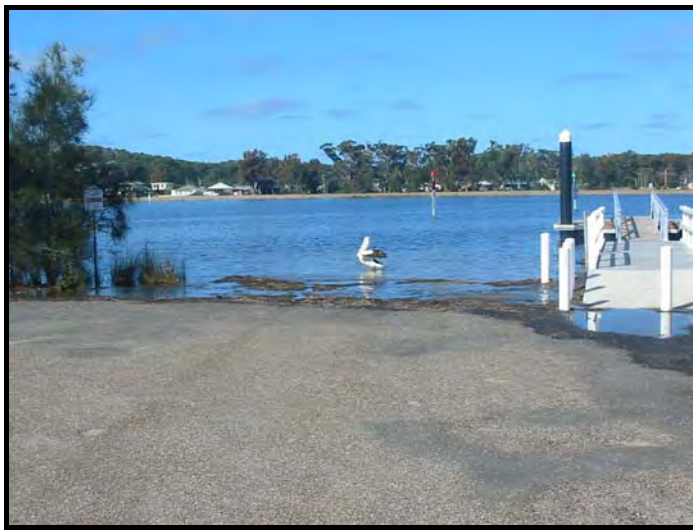
Figure 13 Maria Ave ramp with lake at 0.8m AHD

The Maria Avenue boat ramp (**Figure 13**) is usable (albeit with some difficulty due to the low approach road) at lake levels up to 1.1m AHD. However the edges of the ramp are not marked and reportedly one boat trailer has diverted over the western edge, with some difficulty of retrieval. It would be a simple matter to mark the ramp approaches and the western edge to provide orientation when launching and retrieving vessels.

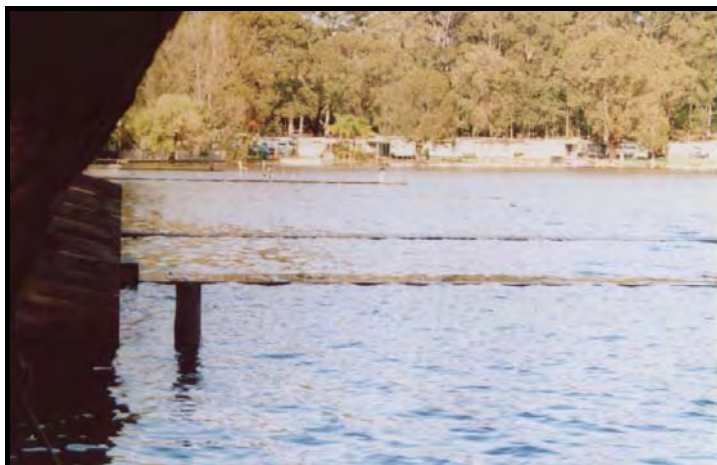
Figure 15 Lake View Road jetties at a lake level of 0.9m AHD

Many lake frontage houses at Burrill Lake have leases over Crown Land for a private jetty. Standards and elevations vary, with these structures having a deck level varying from about 0.75m to 1.3m AHD. (By comparison, the recently constructed Council fishing platforms have been intentionally designed with a bearer level of 1.25m AHD to remain above elevated lake waters.)

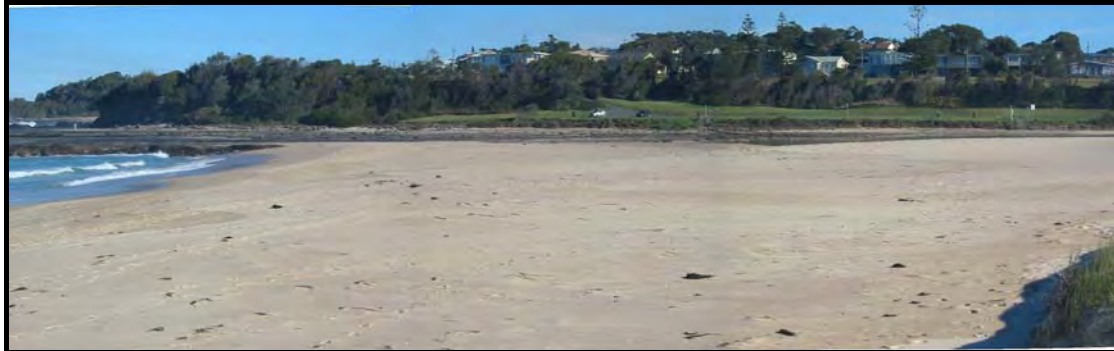
Figure 16 Closed entrance 8th August 2006 looking south

Following lake closure, the entrance berm would be expected to grow by the onshore movement of beach sands. **Figure 16** taken on 8th August 2006 shows a berm in the processes of accretion.

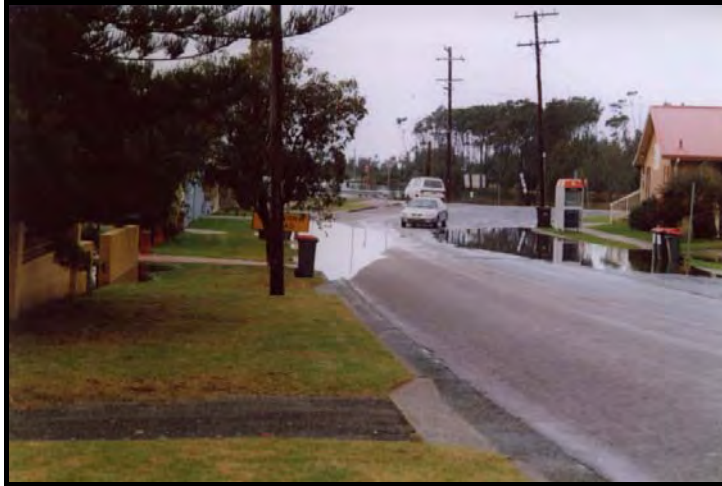
Figure 18 Balmoral Road looking east towards Princes Hwy intersection - June 2005 (lake level approx 1.05m AHD)

Figure 18 shows inundation of Balmoral Road at about 1.05m AHD in early June 2005. Water backs up stormwater drains and runs along the kerb and onto the roadway. This road is the only road in and out of the southern area of Burrill Lake and the locality shown is some 50 meters from the Princes Highway intersection. This is an unsustainable situation to manage for any length of time beyond a day or so. The traffic safety issue would be of concern specifically in peak tourist season where visitors to the area may not be familiar with flood potential, particularly at night.

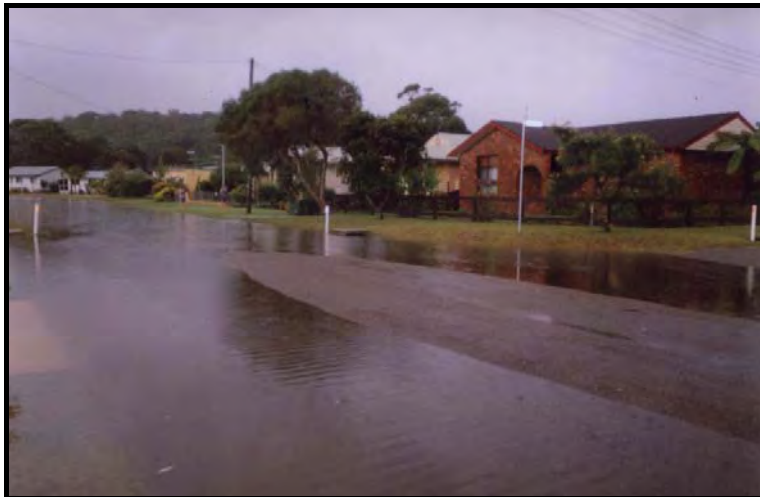
Inundation of Thistleton Drive in **Figure 19** shows an area, well removed from the lake, affected by a compromised stormwater system. The invert of the grassed swale drain at this location (concrete pit cover is visible in the figure below) is 0.95m AHD. The road level is about 1.1m AHD. Thistleton Drive is not a busy road and access from either direction is available. The traffic safety issue could be managed by signage. Storm flaps on pipe outlets would not assist in this case as the issue appears related to flat pipeline grade / limited capacity under a high tailwater (lake) level. Stormwater flaps would only serve to decrease pipeline capacity.

Figure 19 Thistleton Drive (cnr. Ronald Ave) - June 2005 (stormwater backing up from surcharged pipes after heavy rainfall)

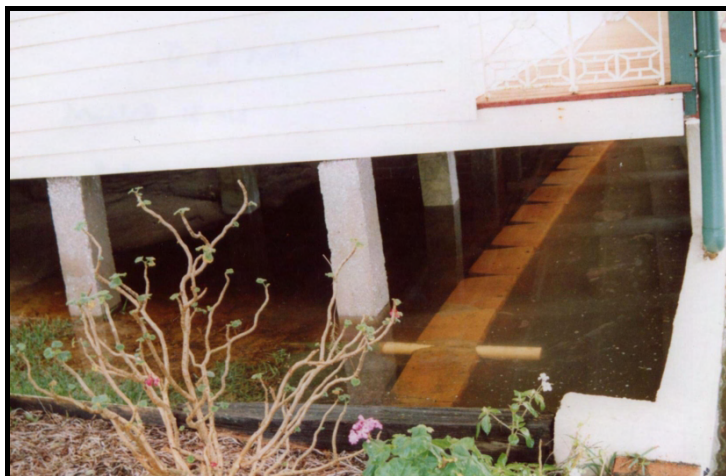
Figure 20 shows a Burrill Lake residence with footing pads under some 250mm of water.

Figure 20 Water below lake frontage residence June 2005

While this locality appears to be one of the lowest residential under-floor surface levels (without the house floor being inundated), at least four other residents report similar experiences.

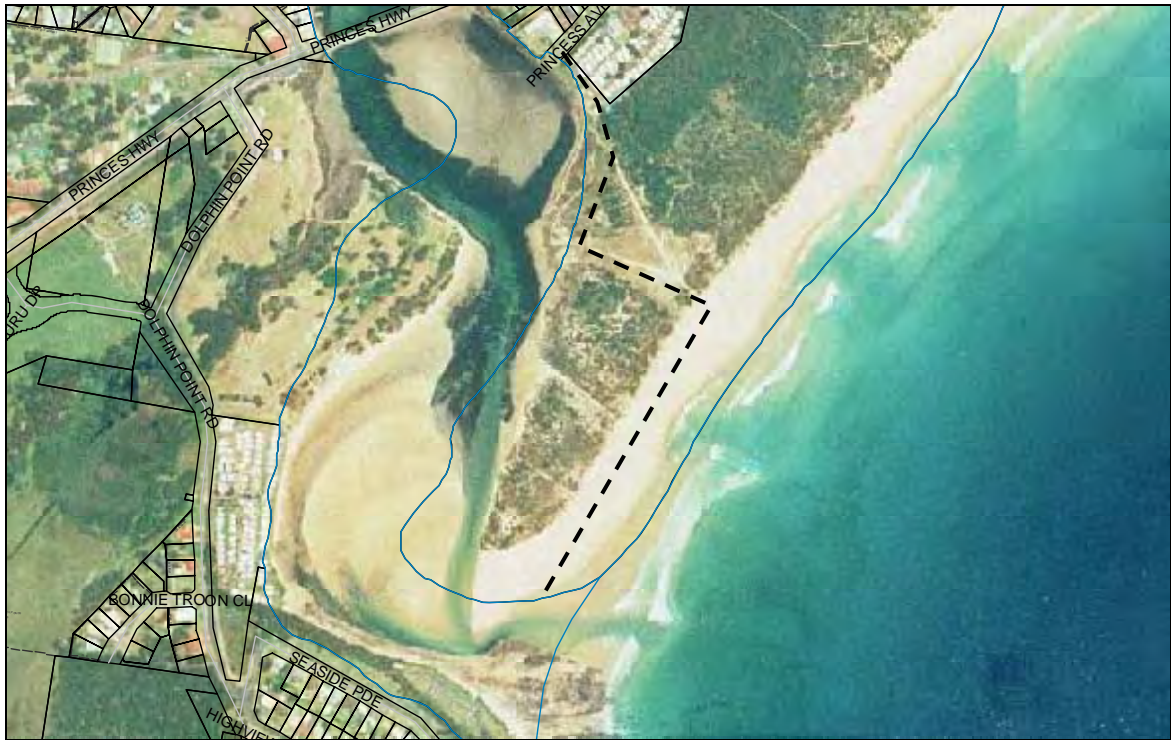
The opening should be sufficient for scour flow to develop. The preferred pilot channel size is 2 m wide with the bed graded to the ocean. An excavator would access the entrance along the route specified in the REF as shown in **Figure 21**. It will cut the channel, pushing the excavated sand as far as is feasible from the cut face. Normally excavation will commence at the ocean, working back to the lake. This procedure could be reversed, leaving a 'plug' of sand at the lake edge, should high seas hamper excavation at the ocean.

Figure 21 Preferred excavator access route to entrance
