Lake Conjola Coastal Management Program Stage 2 Determine Risks, Vulnerabilities and **Opportunities**

Report C - "Entrance Processes and Entrance Management Options"

Shoalhaven City Council

Reference: PA2591-SCC-CMP-Stage 2 Report C-0003

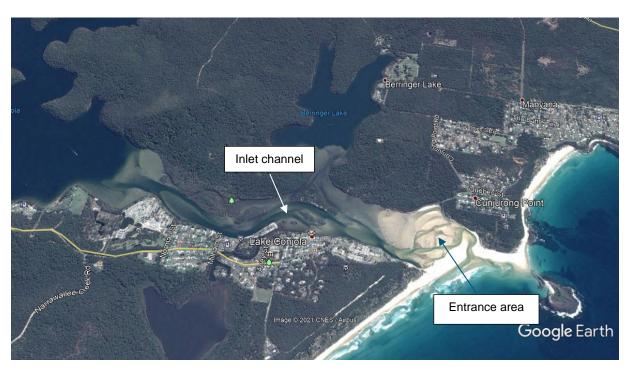
Figure 2-1: Aerial view of Lake Conjola showing the entrance area and the inlet channel

Astronomical tide is a key 'forcing' mechanism for water movement and sediment movement in the lake entrance area and further upstream within the inlet channel (refer **Figure 2-1**). The other key forcing mechanism is freshwater discharge from the lake at times of rainfall. During dry periods, freshwater flows are insignificant and tidal and wave driven processes dominate entrance behaviour.

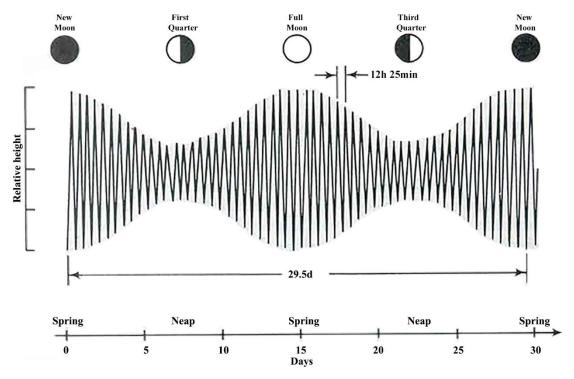
Figure 2-2: Astronomical tide behaviour in the ocean

When the moon, sun and the earth are in line their combined attraction is stronger and the ocean tidal range (height difference between high tide and low tide) is greater. This is referred to as spring tides and occurs on approximately a fortnightly cycle around the time of the new moon and full moon. Neap tides (lower tidal range) occur when the sun and moon are at right angles relative to the earth and their gravitational effects act in opposition. The neap tide follows seven days after a spring tide, during the first and third quarters of the moon. The above astronomical tidal behaviour along the coast is depicted in **Figure 2-2**.

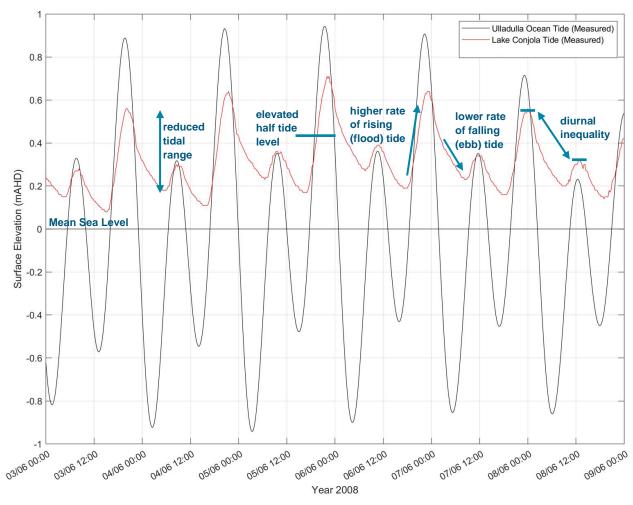
Figure 2-3: Water level behaviour in Lake Conjola compared to the ocean

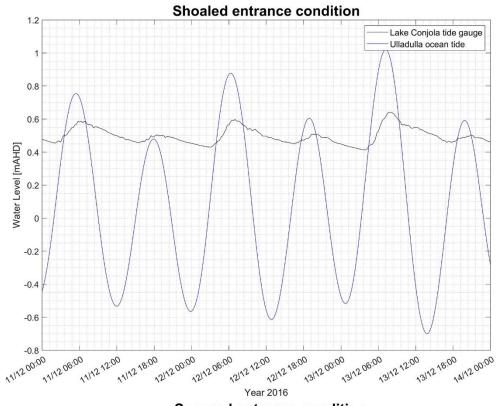
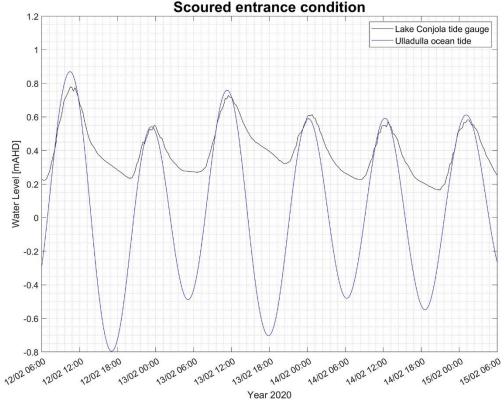
Figure 2-4: Tidal behaviour for a scoured entrance condition following the February 2020 flood event (top panel) and for a heavily shoaled condition in December 2016 (bottom panel)

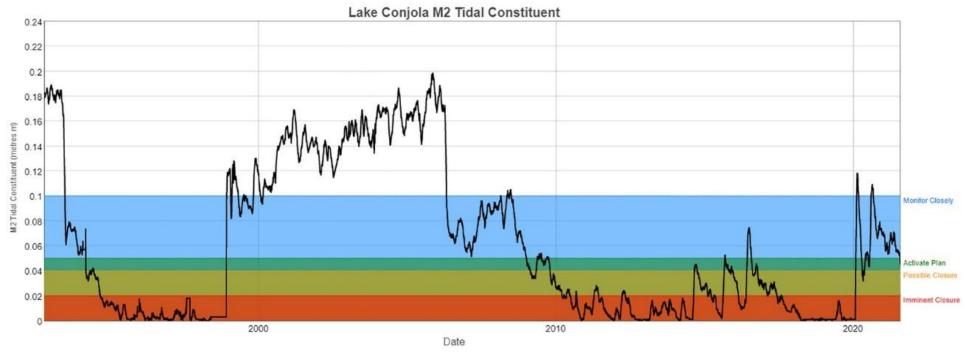
Figure 2-5: Lake Conjola M2 tidal constituent time – series and associated guidance on entrance closure (from: https://mhlfit.net/users/ShoalhavenCityCounci-LakeConjolaM2)

Due to the dependence between lake water level behaviour and entrance condition, Manly Hydraulics Laboratory (MHL) has developed a tool for Council which monitors a component of the variation in lake water level (being the M2 tidal constituent<sup>4</sup>) as a proxy for the various stages of the entrance closure of Lake Conjola (refer **Figure 2-5**). Plotting of the M2 tidal constituent can be used as a remote monitoring indicator of the degree of lake entrance constriction, and potential for closure. As illustrated on **Figure 2-5**, a higher M2 value indicates a well-scoured open entrance condition and a reduction in M2 value indicates progressive shoaling and possible imminent closure of the entrance.

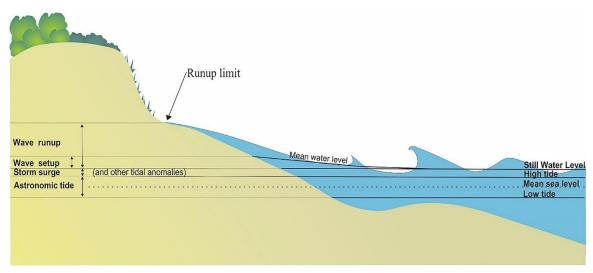
Figure 2-6: Components of coastal water level

At times of coastal storms, the water level along the open coast becomes elevated above astronomical tide due to the effects of storm surge, wave setup and wave runup. These factors are illustrated diagrammatically in Figure 2-6 and discussed below.

Typical magnitudes of storm surge in severe storms are 0.3 to 0.5m. Wave setup along the open coast is much more significant and in severe storms is in the range 1 to 1.5m.

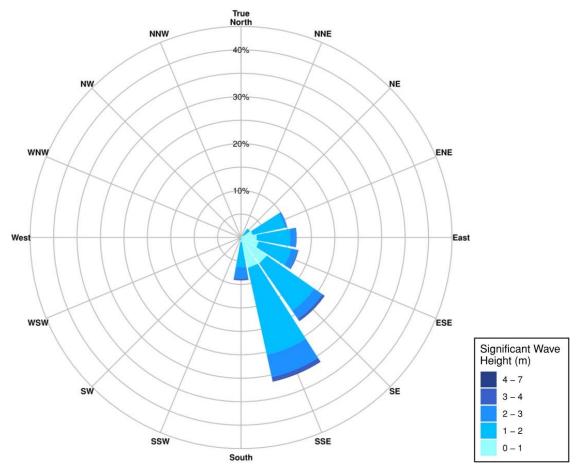
Figure 2-7: Wave rose for the Batemans Bay waverider buoy station (source: Manly Hydraulics Laboratory)

**Figure 2-7** presents a wave rose (percent occurrence of significant wave height and direction) for the Batemans Bay waverider buoy station based on 18.9 years of directional wave data<sup>5</sup>. This figure demonstrates that the majority of waves, and the highest waves, recorded offshore of Batemans Bay are from the south-east (SE) and south-south-east (SSE). This predominant wave direction and wave height, and the generally north-east alignment of the coastline at the Lake Conjola, gives rise to a net northerly sand transport (littoral drift) along Conjola Beach and explains the sand spit growth at the entrance from south to north thereby forcing the entrance channel against the northern shoreline at Cunjurong Point (refer **Section 2.5**).

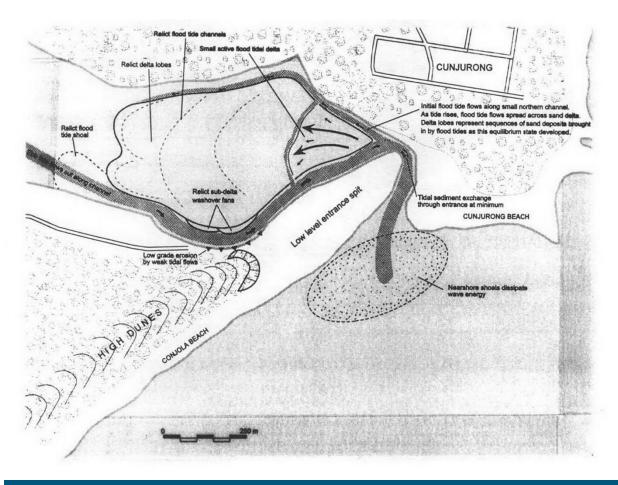
### **Regime Entrance State - Broad features:**

- entrance is hard against the northern shoreline and the channel is quite narrow;
- small tidal exchange with limited tidal range in lake average lake level is elevated well above mean sea level;
- flood tide delta and low level entrance spit relatively stable but prone to instability from:
  - floods cutting through spit and opening up lake and rejuvenating tidal exchange,
  - severe coastal storm overtopping the entrance sand spit and pushing large deposits of sand westwards and potentially closing the entrance,
  - lengthy dry spell (several years) allowing windblown sand to slowly close off the narrow entrance channel.

Figure 2-8: Regime entrance state

Characteristic entrance state	Description
Regime Entrance State	A steady end state that the entrance naturally and gradually establishes in the absence of any sudden changes caused by major floods and ocean storms. This is a state of near dynamic equilibrium. Refer <b>Figure 2-8</b> .
Flood Scoured Entrance State	The entrance state resulting from a sudden change caused by a significant flood leading to a net loss of sand from the entrance shoals and widening of the entrance. Refer <b>Figure 2-9</b> .
Intermediate Entrance State	The entrance state associated with relatively rapid infilling of entrance shoals after a major flood and before the regime state is reached. The intermediate state was considered to progress to the regime state over a period of 1 to 2 years. Refer <b>Figure 2-10</b> .
Storm Washover Entrance State	The entrance state associated with a sudden change caused by major to severe ocean storm waves washing sand over the entrance sand spit leading to blocking of the entrance channel. Entrance closure is likely to ensue from this state. Refer <b>Figure 2-11</b> .

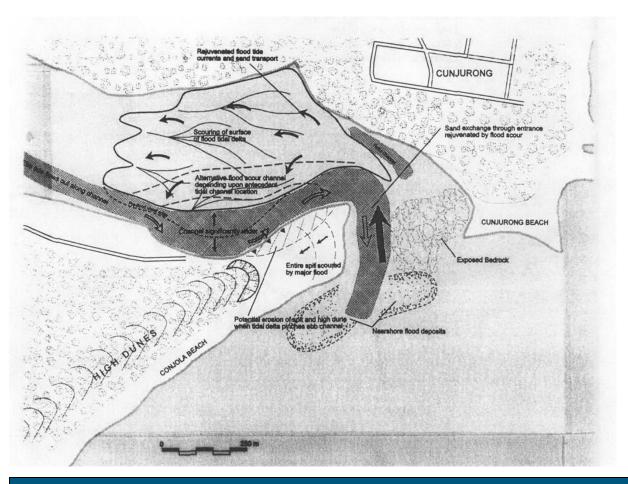
### Flood Scoured Entrance State - Broad features:

- scour expands entrance throat, enlarging channel more to the south;
- flood tide delta scoured at southern edge and over entire surface (evidenced by channelling pattern);
- flood scour deposits placed in nearshore zone as large shallow bar;
- due to proximity of flood sediment deposits and increased tidal flows, the entrance is primed for:
  - rapid onshore movement of previously flood scoured deposits combined with normal longshore transport of sand from Conjola Beach into the entrance area,
  - pronounced net infeed of sediment thereby increasing shoal build-up across flood tidal delta.

Figure 2-9: Flood scoured entrance state

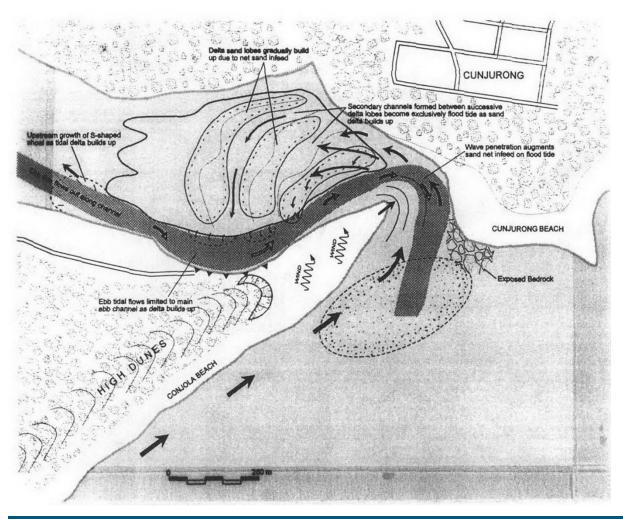
#### **Intermediate Entrance State - Broad features:**

- sediment has mobilised into entrance via onshore movement of flood deposits as well as longshore and wind transport, viz:
  - entrance spit has migrated northwards,
  - flood tidal delta lobes have built up significantly,
- · these changes combine to reduce tidal flows, though there is still a net infeed of sediment;
- entrance will gradually reduce unless reopened by a flood;
- closure may be catalysed by storm supply of large amount of sediment.

Figure 2-10: Intermediate entrance state

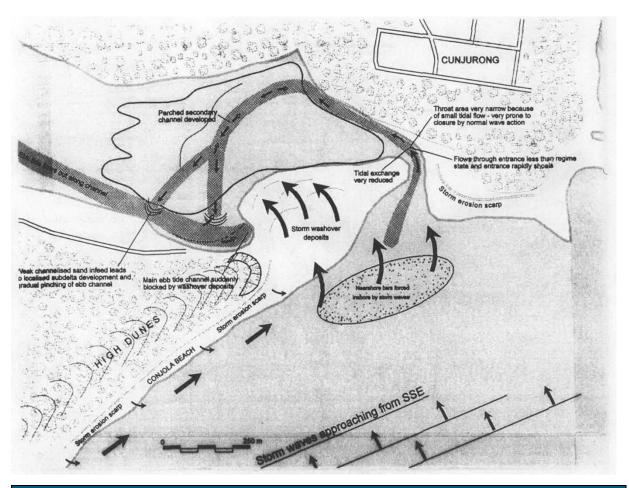
#### Storm Washover Entrance State - Broad features:

- washover deposits i.e. 'fans' cut off fluvial channel/primary ebb channel;
- ebb channel becomes perched on flood delta lobes leading to suddenly and substantially diminished tidal flows;
- flood tide tends to re-establish northern perimeter channel;
- sediment infeed is reduced but continues to pinch primary ebb channel which eventually disappears;
- · further washover leads to closure.

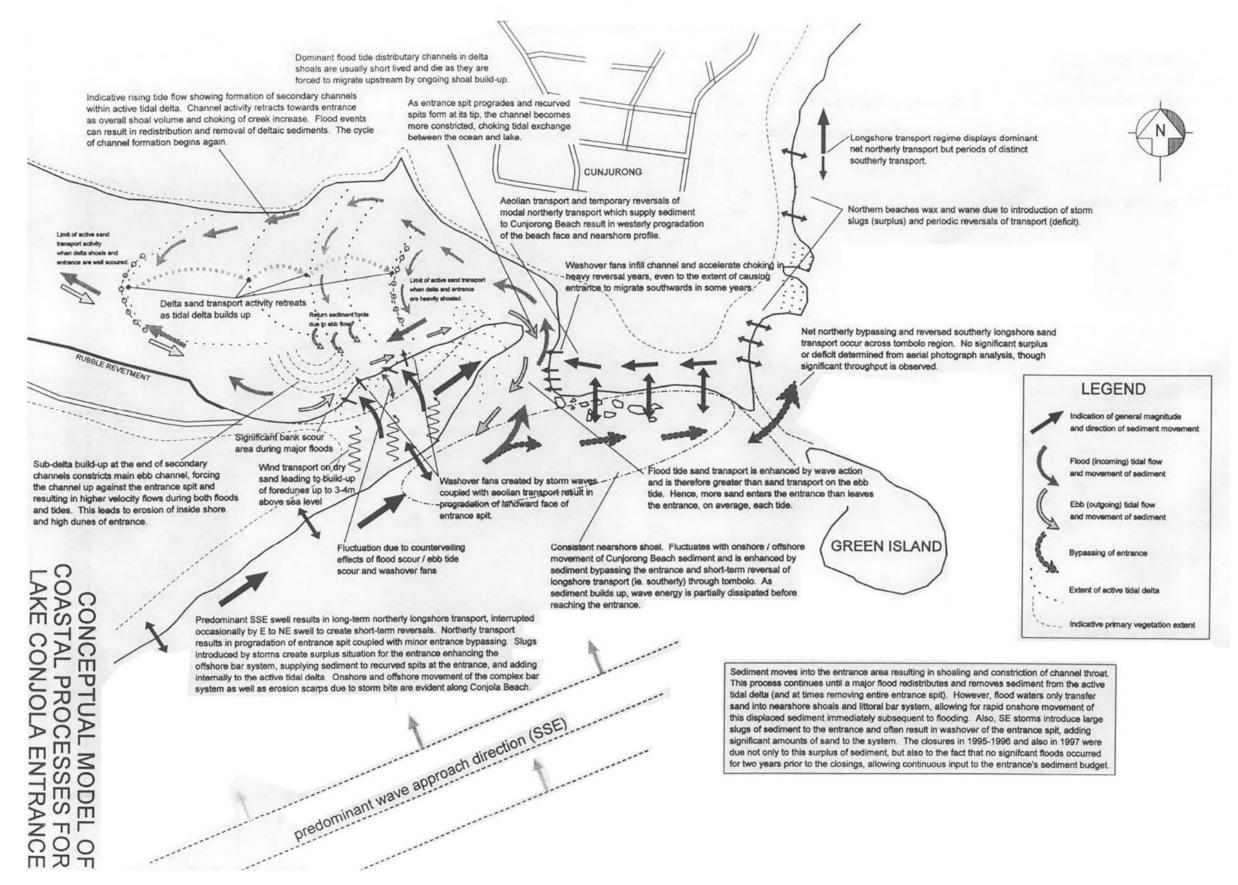
Figure 2-12: Conceptual model of sedimentary processes at Lake Conjola entrance (from Patterson Britton, 1999)

The detailed conceptual model included in Patterson Britton (1999) is reproduced in **Figure 2-12**. The key features of the conceptual model are summarised below. Quantification of the various sedimentary processes was also included in Patterson Britton (1999) but this level of detail is not presented here.

- the northern shoreline exhibits reduced exposure to waves due to the wave shadow caused by Green Island and the dissipative effects of the nearshore shoals:

- there is a northerly leakage of longshore sand transport between Green Island and Cunjurong headland, occurring as sand 'slugs' during southerly storms;

- the indented shoreline in the southern boat ramp area, including the large bay and beach to the east in the vicinity of the beach access walkway, is present in the earliest photos of the area. It has evolved due to repeated southerly progradation of the tidal delta during periods of sustained delta build-up.

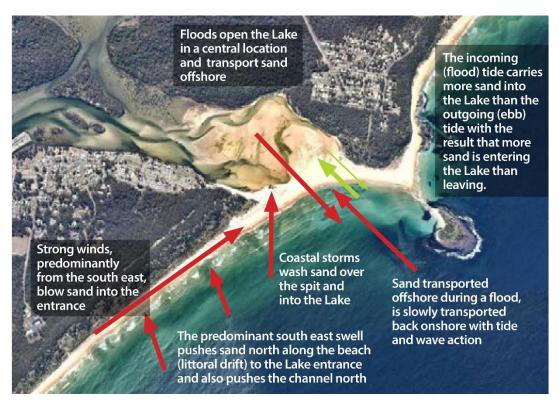
Figure 2-13: Simplified model of sedimentary processes at Lake Conjola entrance (from Coastal Fact Sheet, 2018)

The simplified conceptual model of sedimentary processes operating at the entrance to the lake included in Council's Coastal Fact Sheet – Lake Conjola Management (refer **Appendix C**) is reproduced in **Figure 2-13**. This shows the main sediment transport pathways.

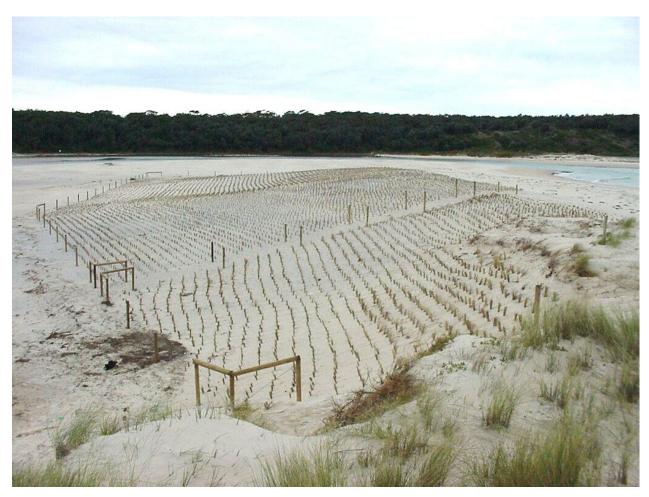
Figure 2-14: Dune revegetation at Lake Conjola entrance (source: DPE)

- entrance closures are caused by severe storms;
- periods of entrance stability correspond with periods of little storm activity; and,
- the key to improving entrance stability (reducing the likelihood of entrance closure) is reducing the
  destabilising impact of severe storms, i.e. preventing or mitigating storm washover deposits<sup>8</sup> (refer
  Figure 2-14 which shows dune stabilisation works completed by Council in 2004 in response to
  conclusions in Patterson Britton (1999)).

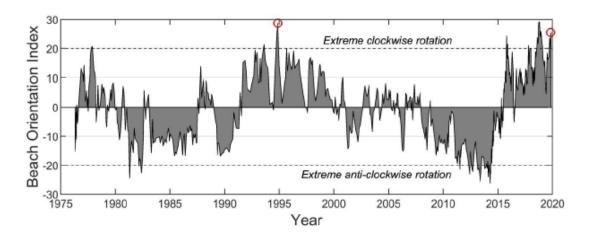
Figure 2-15: Time-series of the Beach Orientation Index at Collaroy-Narrabeen Beach (1976-2019). The November 1994 and November 2019 periods of extreme clockwise rotation are indicated in red.

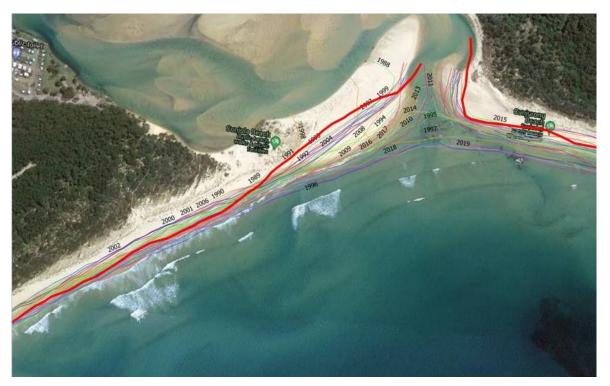
Figure 2-16: Selected plots of water line position along the beach near the entrance to Lake Conjola over the period 1990-2019 from satellite imagery

**Figure 2-16** shows the position of the water line along the beach near the entrance to Lake Conjola over the period 1990 to 2019, mapped from satellite imagery as part of this study. It is evident that the most clockwise alignment of the beach is in the years 1996 and 2019. These two years correspond to the strong clockwise rotation observed at Collaroy-Narrabeen Beach and which also correspond to periods of closure of Lake Conjola entrance based on the Council spreadsheet records referred to in **Section 2.5.4** and included in **Appendix E**.

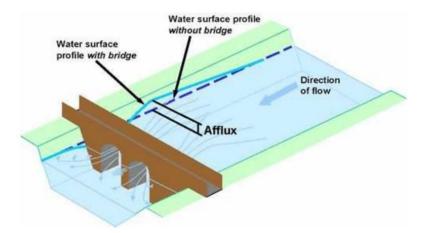
Figure 2-17: Afflux at a bridge crossing

It was also noted that, at a local level, flooding between Pattimores Lagoon and the lake could be exacerbated by the afflux (refer **Figure 2-17**) caused by the restriction at the Lake Conjola Entrance Road bridge.

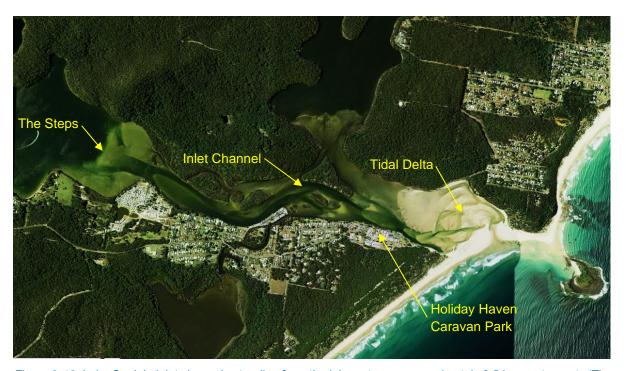
Figure 2-18: Lake Conjola inlet channel extending from the lake entrance approximately 3.5 km upstream to 'The Steps'

Park, and the second within the main lake waterbody upstream of the limit of the inlet channel, about 3.5km from the lake entrance (a location known as 'The Steps') (refer **Figure 2-18**). The difference (flood level increase) between the peak flood levels for the closed entrance case versus the open entrance case, for each design flood event, is also shown in the table.

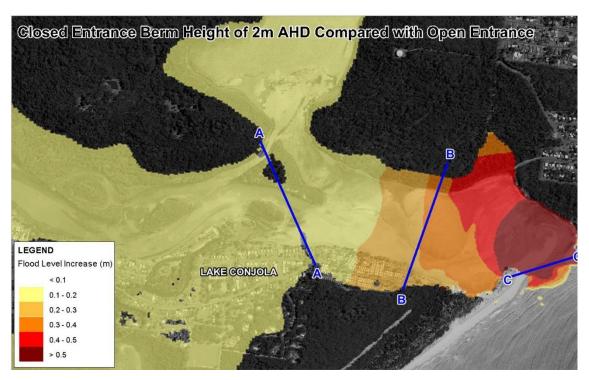
Figure 2-19: Impact on peak flood level of closed entrance with berm level of 2m AHD compared to open entrance for 1% AEP event (from BMT WBM, 2013b)

BMT WBM acknowledged that if the entrance berm did approach 2m AHD such conditions would start to influence peak flood levels significantly in the broader entrance area (for the 1% AEP event, refer Figure 2-19). Impacts would be expected to be of greater significance for more frequent events such as the 20% AEP and 10% AEP events, based on the results presented in **Table 2-3**.

The increase in peak flood level for a closed entrance with a berm level of 2m AHD versus an open entrance, for the 1% AEP event, is shown in Figure 2-19. At the downstream limit of the Council Holiday Haven Caravan Park this increase is 0.2 to 0.3m.

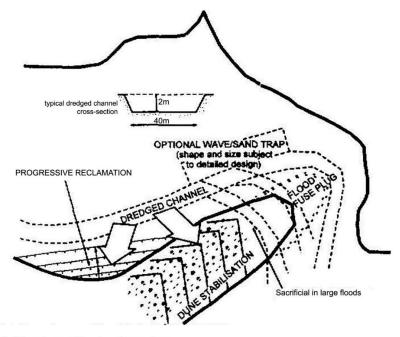
- Stabilise entrance spit to reduce storm washove
- Monitor entrance conditions
- Maintain fuse plug at northern tip of spit to suit flood flows (1.0-1.5m AHD)
- When close to closure according to a new Entrance Management Policy, dredge new channel along path
- of historic flood cuts to substantial dimensions, ie 40m x 2m deep

Figure 3-1: Schematic of the 'managed entrance' option considered in Patterson Britton (1999)

The managed entrance option involved four main elements and is depicted schematically in Figure 3-1:

<sup>&</sup>lt;sup>19</sup> The fuse plug comprised an unvegetated area at the northern tip of the sand spit of sufficient dimensions such that scour could occur during flooding events and release flood waters to mitigate flood impacts.

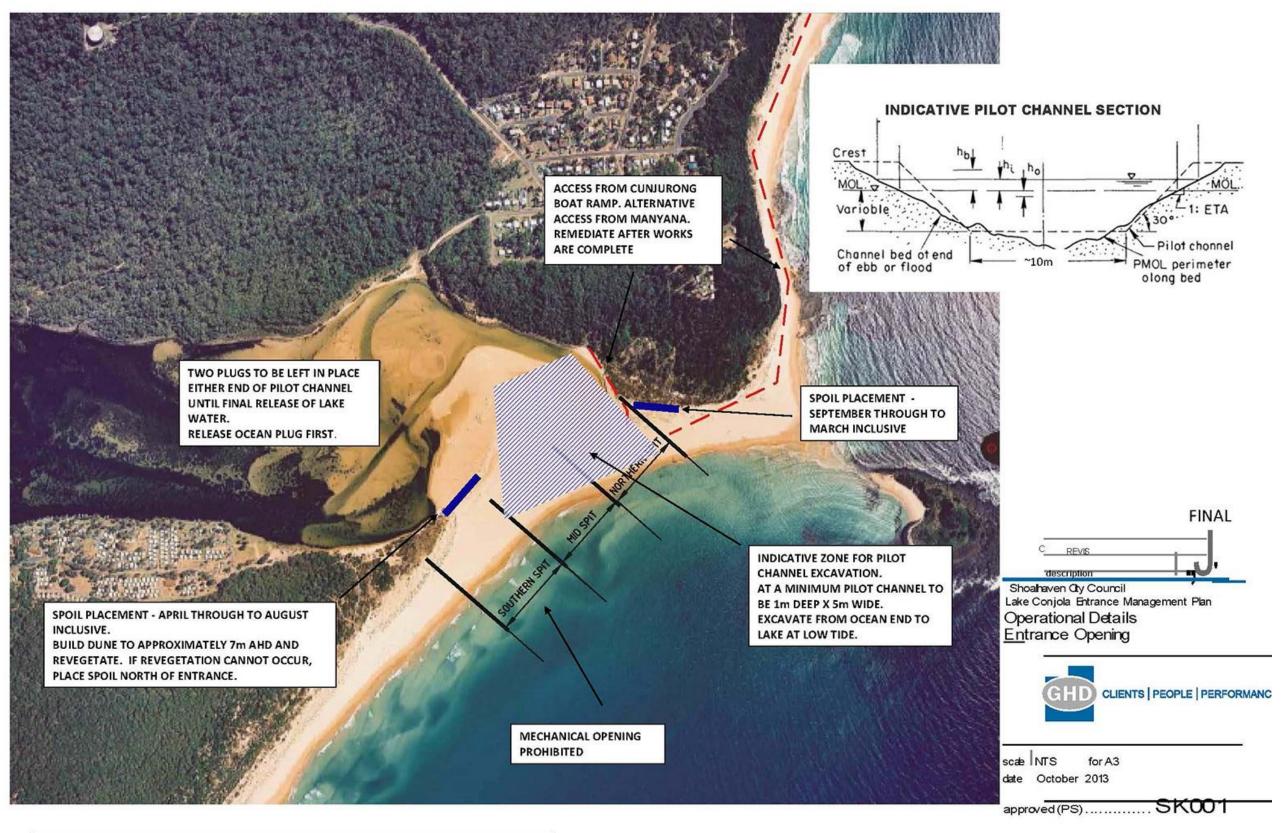
NOTE: PILOT CHANNEL DIMENSIONS WILL CHANGE DEPENDING ON LEVEL OF BERM AT TIME OF EXCAVATION

Figure 3-2: Operational details included in the Interim Entrance Management Policy (GHD, 2013)

Appendix C of Interim Entrance Management Policy set out 'Operational Details' for implementation of the Policy, comprising an aerial photograph of the entrance area marked up with operational notes and is reproduced in **Figure 3-2**. Some key points in the operational details are as follows:

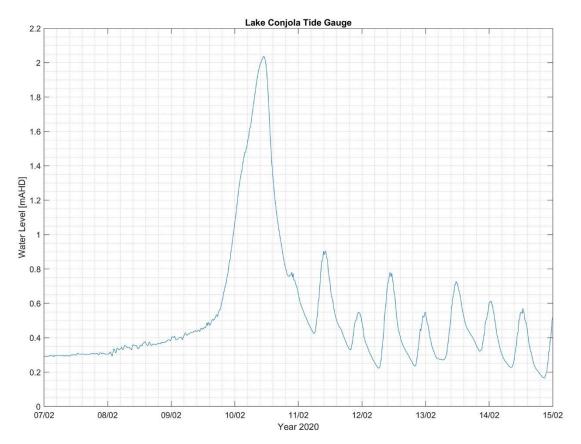
Figure 3-3: Lake water level over the period 7-14 February 2020 showing the breakout on 10 February

The lake water level preceding and following the mechanical opening on 10 February 2020 is shown in **Figure 3-3**. It shows the very rapid rise in water level during the evening of 9 February and morning of 10 February over a period of approximately 15 hours (7pm to 10am), the rapid lowering of the water level over a similar period following the opening, and the subsequent strong tidal response through the scoured entrance.

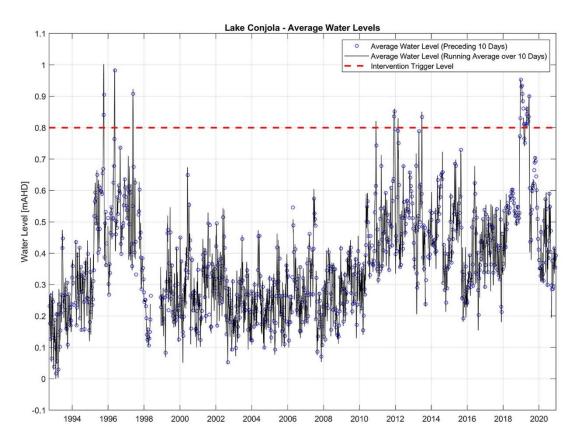
Figure 3-4: Variation in 10-day-mean lake water level over the period 1992-2021

An assessment has been made of whether the intervention trigger for prolonged low-level inundation would have been activated over the period of time for which lake water data is available, namely the period from 1992 to 2021. **Figure 3-4** shows the 10-day-mean water level over this period of time calculated by two methods. It is evident there are only two occasions when the intervention trigger was approached (not reached), being during the period December 2018 to June 2019.

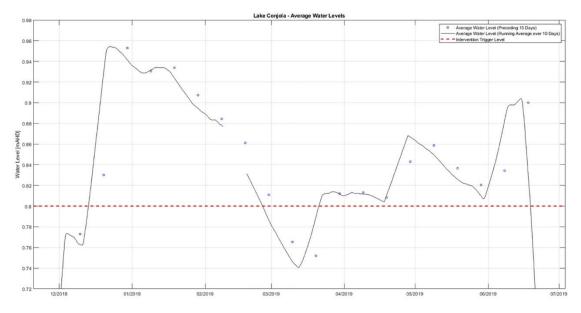
Figure 3-5: Zoomed-in lake water level over the period December 2018 - June 2019

A zoomed-in view of the lake water level over the period December 2018 to June 2019 is shown in **Figure 3-5**. The second elevated water level period March-June is slightly longer than the first period December-March but is just below the trigger duration of 3 consecutive months. Accordingly, the intervention trigger for prolonged low-level inundation, as defined in the Crown Lands Licence: RN625288, would not have been activated over the 29 year period 1992-2021.

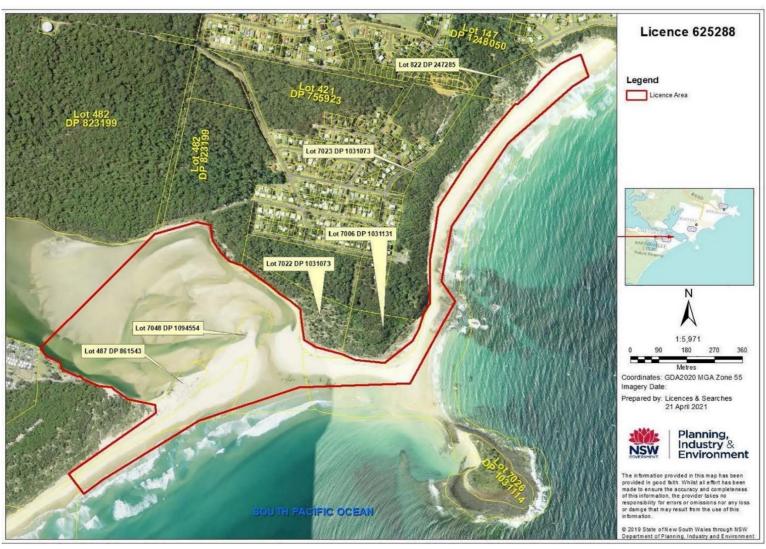
Figure 3-6: Extent of Licence Area in Schedule 3 of five year Crown Lands Licence

The map included in Schedule 3 of the Licence showing the Licence Area is reproduced in **Figure 3-6**. The area extends within the lake from the Cunjurong foreshore to the Conjola foreshore and upstream over a large portion of the flood tide delta, extends to the south of the entrance along Conjola Beach, and extends northwards around Cunjurong Point and along Manyana Beach. The extent of the Licence Area takes into account potential disposal areas for excavated sand in addition to the potential excavated channel locations.

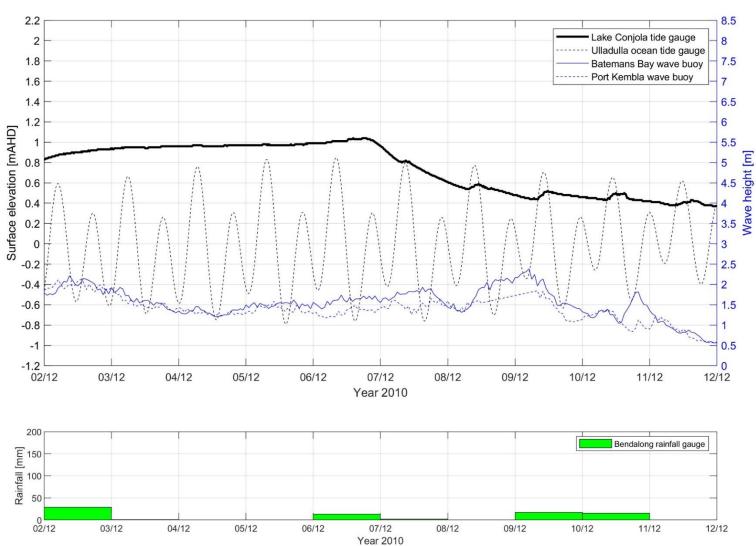
- the water level in the lake slowly increased over the days prior to the opening, reaching a level of approximately 1.1m AHD at the time of the opening;
- only relatively minor rainfall preceded the opening;
- the offshore wave climate was mild at the time of the opening (Hs in the range1.5 to 2m);
- the lake water level dropped by 0.55m, from 1.1m AHD to 0.55m AHD, over a period of about 2.5 days following the opening (0.35m/day); and,
- the tidal response in the lake following the opening was relatively minor (tidal range less than 0.1m) indicating the breakout channel was not particularly well developed. According to the records of entrance stability, the entrance closed in early March 2011 after a period of about three and a half months and an emergency opening had to be completed on 21 March 2011 (refer Appendix D).

Figure 4-1: Water level, rainfall, and wave records for the mechanical opening on 7 December 2010

**Table 4-3** sets out a summary of a number of features of the mechanical openings by Council and the natural opening, as described in the previous sections. Based on this summary and observation of the relationships between water level, rainfall, and wave records in **Figure 4-1**, **Figure 4-2**, **Figure 4-4**, **Figure 4-5**, **Figure 4-6**, **Figure 4-7**, **Figure 4-12** and **Figure 4-15**, the following general concluding remarks can be made:

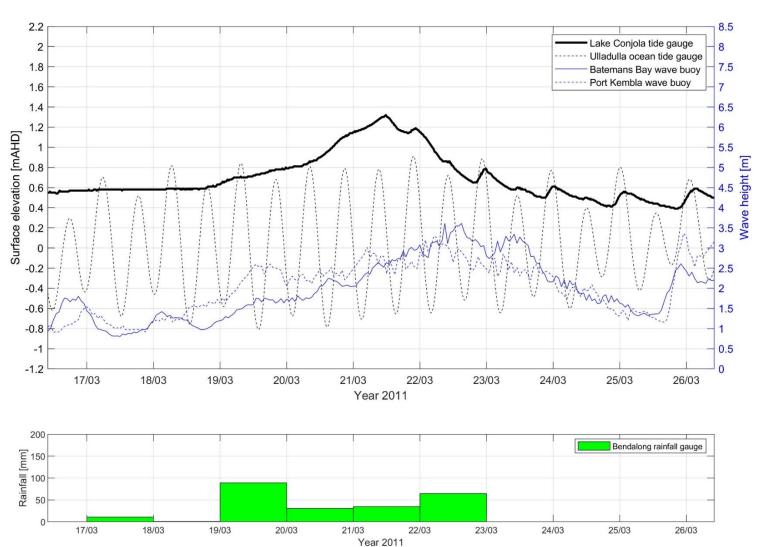
The records of water level, rainfall, and offshore wave height prior to and following the opening on 21 March 2011 are shown in **Figure 4-2**. A number of features are evident:

- the water level in the lake was initially around 0.6m AHD but rose in response to rainfall and reached a peak of approximately 1.3m AHD at the time of the opening;
- the offshore wave climate was relatively mild at the time of the opening (H<sub>s</sub> in the range 1.5 to 2.5m), although H<sub>s</sub> increased to approximately 3.5m after the opening;
- the lake water level dropped by 0.7m, from 1.3m AHD to 0.6m AHD, over a period of 1.5 to 2 days following the opening (0.4m/day), so at a greater rate than for the opening on 7 December 2010, indicating a stronger breakout flow; and,
- the tidal response in the lake following the opening was stronger than for the opening on 7 December 2010 (tidal range 0.1 to 0.2m), also indicative of a more well developed breakout channel (less shallow water effects on tidal propagation).

Figure 4-2: Water level, rainfall, and wave records for the mechanical opening on 21 March 2011

The above outcome indicates the benefit of a higher initial lake water level at the time of an opening in generating greater scour and a more well developed channel, which may have been assisted in this case by continuing rainfall generating discharge through the entrance following the opening.

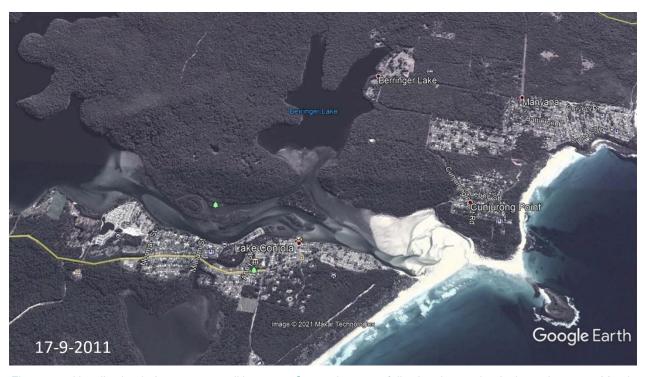
The period of time for which the entrance remained open is not documented but it is apparent from aerial photographs that the entrance was heavily shoaled in September 2011 some six months after the opening (refer **Figure 4-3**).

Figure 4-3: Heavily shoaled entrance condition on 17 September 2011 following the mechanical opening on 21 March 2011

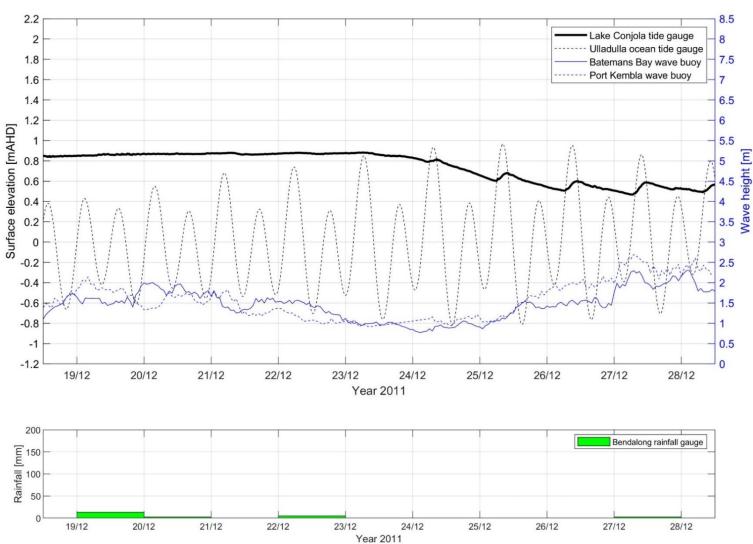
The records of water level, rainfall, and offshore wave height prior to and following the opening on 23 December 2011 are shown in **Figure 4-4**. A number of features are evident:

The short lived open entrance conditions following the mechanical opening in 23 December 2011 would appear to be another example where the entrance channel did not become well developed even though the offshore wave climate was mild, probably as a consequence of the low initial lake water level and absence of rainfall contributing to the discharge through the entrance.

Figure 4-4: Water level, rainfall and wave records for the mechanical opening on 23 December 2011

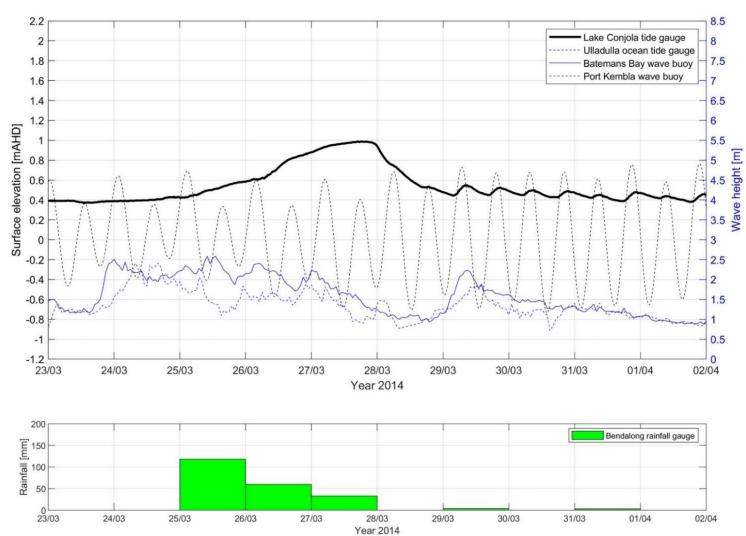
The records of water level, rainfall, and offshore wave height prior to, and following, the opening on 27 March 2014 are shown in **Figure 4-5**. A number of features are evident:

Figure 4-5: Water level, rainfall, and wave records for the mechanical opening on 27 March 2014

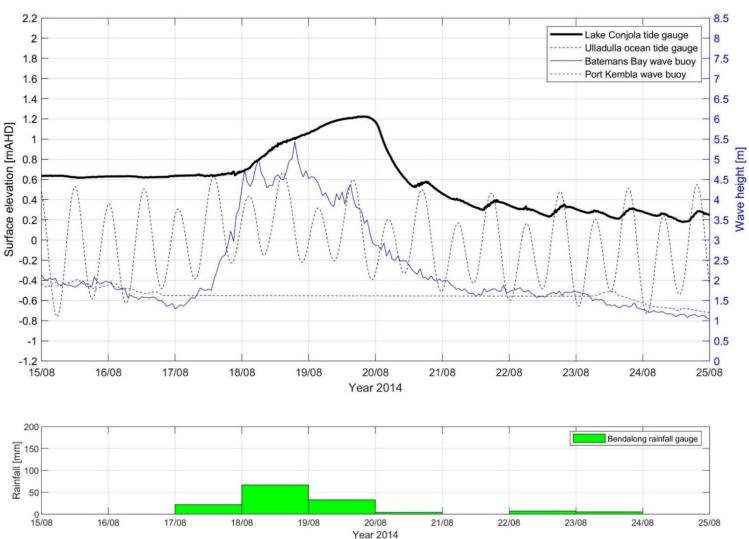
The records of water level, rainfall, and offshore wave height prior to, and following, the opening on 19 August 2014 are shown in **Figure 4-6**. A number of features are evident:

- the tidal response in the lake following the opening was minor to moderate (tidal range 0.1 to 0.2m) indicating the channel is likely to have been more well developed than for the opening on 27 March 2014, possibly due to the higher initial lake water level. The lower ocean high tide may have also been a factor. According to the records of entrance stability, the entrance remained open for a period of 10 months, closing again in June 2015.

Figure 4-6: Water level, rainfall, and wave records for the mechanical opening on 19 August 2014

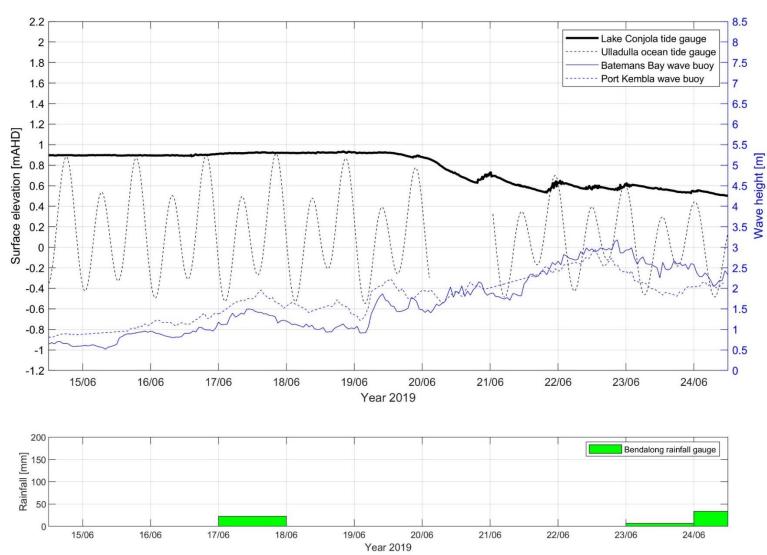
This particular opening ended up being a dredging operation to which Council received a warning letter from Crown Lands. A pilot channel was dug for 4 days prior to 19 July when it was opened, but machinery stayed digging until at least 12 July cutting additional channels and digging in the main ebb channel guided by members of the community. A total of 22,600m³ of sand was ultimately removed and placed on the sand hill to the north of the entrance at a cost of \$140,000, as conveyed in a Council report on the operation.

Figure 4-7: Water level, rainfall and wave records for the mechanical opening on 19 June 2019

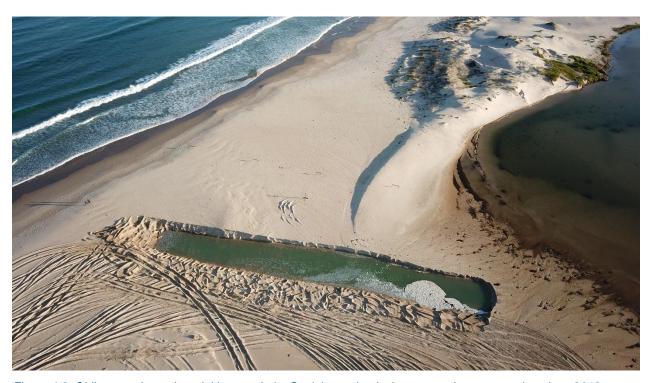
Images of the excavated pilot channel in the June 2019 opening are shown in **Figure 4-8** and **Figure 4-9**. The width of the channel is estimated to be approximately 10 to 12m. The bed of the channel intercepted the water table and is estimated to have been at a level of approximately 0m AHD.

Figure 4-8: Oblique north-south aerial image - Lake Conjola mechanical entrance clearance works - June 2019 (source: Shoalhaven City Council)

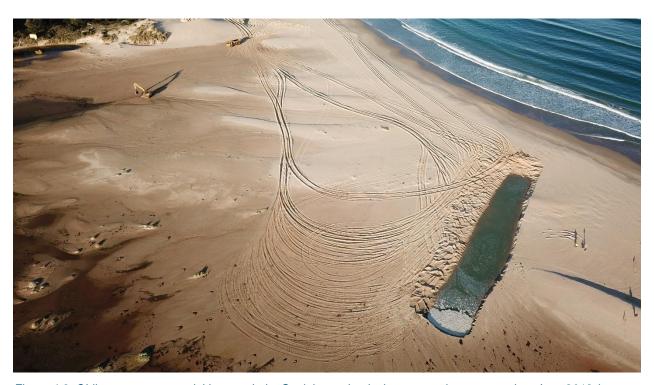
Figure 4-9: Oblique west-east aerial image - Lake Conjola mechanical entrance clearance works - June 2019 (source: Shoalhaven City Council)

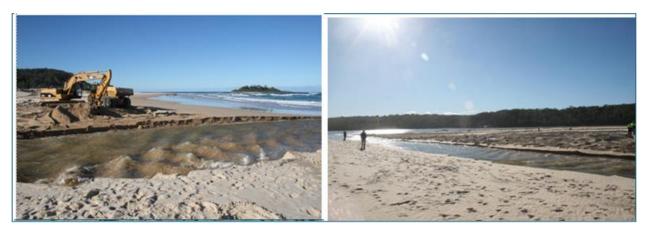
Ground level oblique views of the pilot channel are shown in Figure 4-10.

The plant used on the beach for excavation of the pilot channel typically comprises an excavator (visible in Figure 4-10). Access to the beach is normally via the Cunjurong boat ramp unless access to the beach from the ramp is not possible due to the lake water level and/or foreshore conditions, in which case access is obtained from Manyana to the north. Transport of excavated material across the beach is achieved by use of Moxy dump trucks (visible in **Figure 4-11**).

Figure 4-10: Mechanical opening of Lake Conjola entrance near high tide around 10am 19 June 2019, with water observed flowing out of the lake from around 1:45pm 19 June 2019 (source: D. Wiecek, DPE)

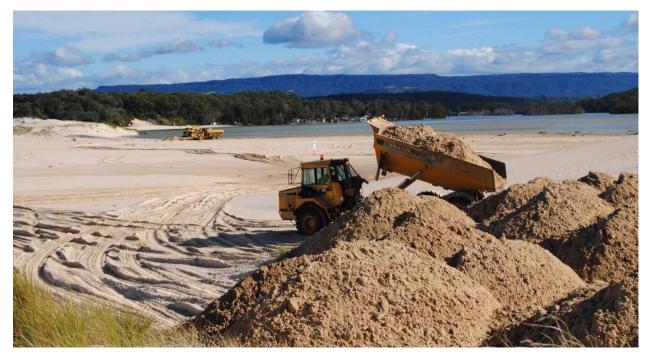
A view of the excavated sand from the pilot channel being placed on the northern side of the entrance area is shown in **Figure 4-11**.

Figure 4-11: Contractors placing sand near northern dunes after removing it from the entrance of Lake Conjola on 13 June 2019 (source: Illawarra Mercury)

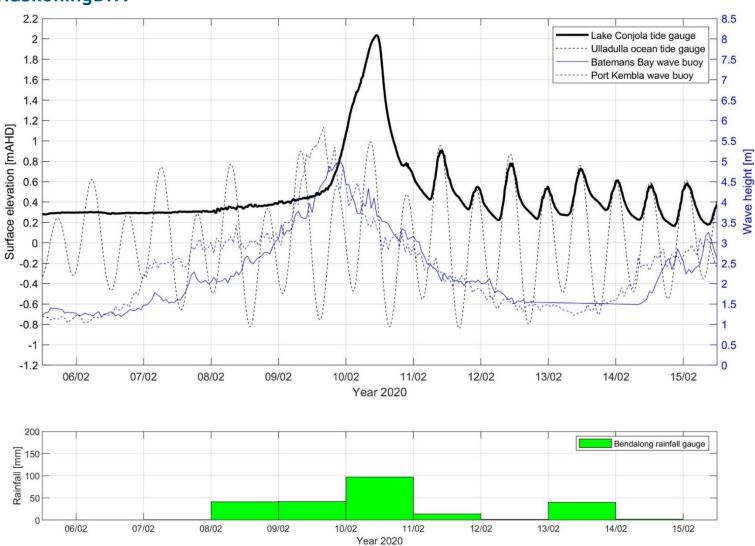
The records of water level, rainfall, and offshore wave height prior to, and following, the opening on 10 February 2020 are shown in **Figure 4-12**. A number of features are evident as outlined below. As noted earlier, significant flooding immediately preceded the mechanical opening in February 2020. The rainfall experienced (the magnitude of which in places was not predicted), Council actions, and the extent of flooding are further discussed in Section 4.4:

Figure 4-12: Water level, rainfall, and wave records for the mechanical opening on 10 February 2020

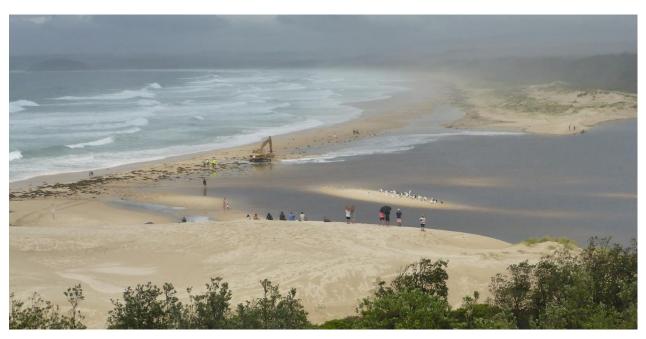
**Figure 4-13** shows excavation of the pilot channel taking place, viewed from an elevated position on Cunjurong Point. **Figure 4-14** shows a close-up view of the channel shortly after commencement of the breakout flow.

Figure 4-13: View of excavation of pilot channel in February 2020 from Cunjurong headland (source: D. Wiecek, DPE)

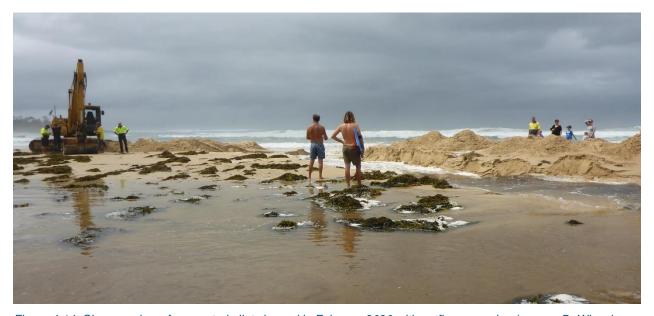
Figure 4-14: Close up view of excavated pilot channel in February 2020 with outflow occurring (source: D. Wiecek, DPE)

<sup>&</sup>lt;sup>29</sup> This very strong breakout flow would have been the consequence of the combination of high initial lake water level (giving a large head difference between the lake water level and the ocean), the short length of pilot channel, and possibly the ongoing rainfall runoff entering the lake and discharging through the entrance channel.

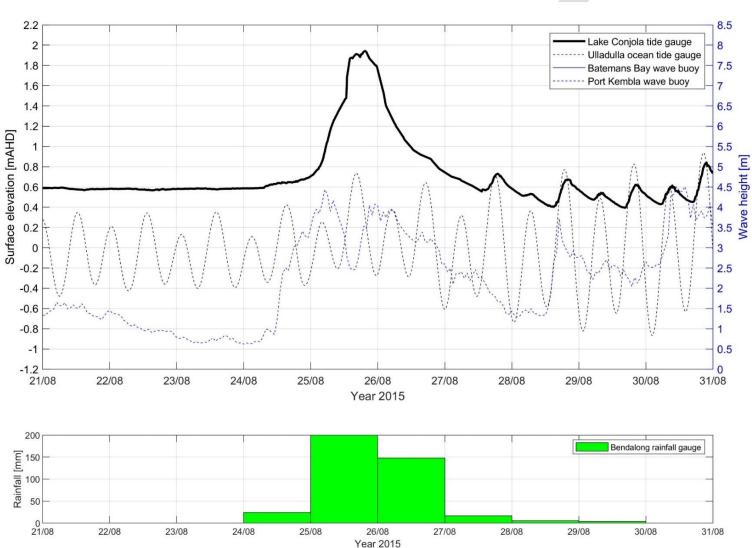
The records of water level, rainfall, and offshore wave height prior to, and following, the opening on 25 August 2015 are shown in **Figure 4-15**. A number of features are evident:

Council email correspondence to agencies at the time confirmed that the lake opened well before the peak of the flood, but the lake water level continued to rise after the opening due to the continuing heavy rainfall (pers. comm Danny Wiecek, Department of Planning and Environment).

Figure 4-15: Water level, rainfall, and wave records for the natural opening on 25 August 2015

- the initial lake water level at times of natural openings is obviously controlled by the sand berm level at the lake entrance. It is evident that when the entrance is closed and the berm level becomes relatively high, and heavy rainfall occurs quickly as was the case in August 2015 (refer Figure 4-15), the lake level can rise rapidly to high levels before natural breaching of the sand berm can occur, being a level of 1.9m AHD in that case. The only way to manage the flooding risk for this type of situation would be to manage the level of the sand berm, e.g. by way of a dry notch.

This document noted that the February 2020 flood was the 10<sup>th</sup> flood experienced at Lake Conjola since 2011. It also included reference to the flooding which occurred at the time of the natural opening on 25 August 2015 (refer **Section 4.3.3** and **Figure 4-15**). In respect of the flood on 25 August 2015 it was stated that the lake opened naturally at a level of 1.2m AHD and the lake water level reached 2.14m AHD<sup>32</sup>.

The peak water level recorded near the entrance on the MHL recorder was approximately 1.9m AHD as indicated in **Figure 4-15**; the level of 2.14m AHD is likely to have been further upstream. It is also noteworthy that the lake is stated to have opened at a level of 1.2m AHD yet the water level reached 2.14m AHD, indicating that the rate of rainfall runoff into the lake in that event exceeded the discharge capacity of the naturally scoured channel.

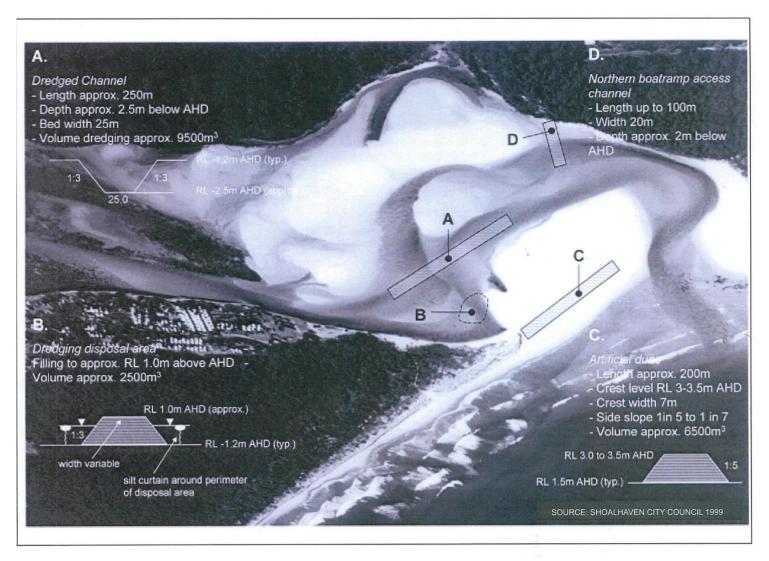
The interim works were carried out from November to December 1999. The location of the works are shown in **Figure 4-19** and involved the following main elements:

Figure 4-19: Stage 1 (Interim Works) dredging and dredge material disposal November to December 1999

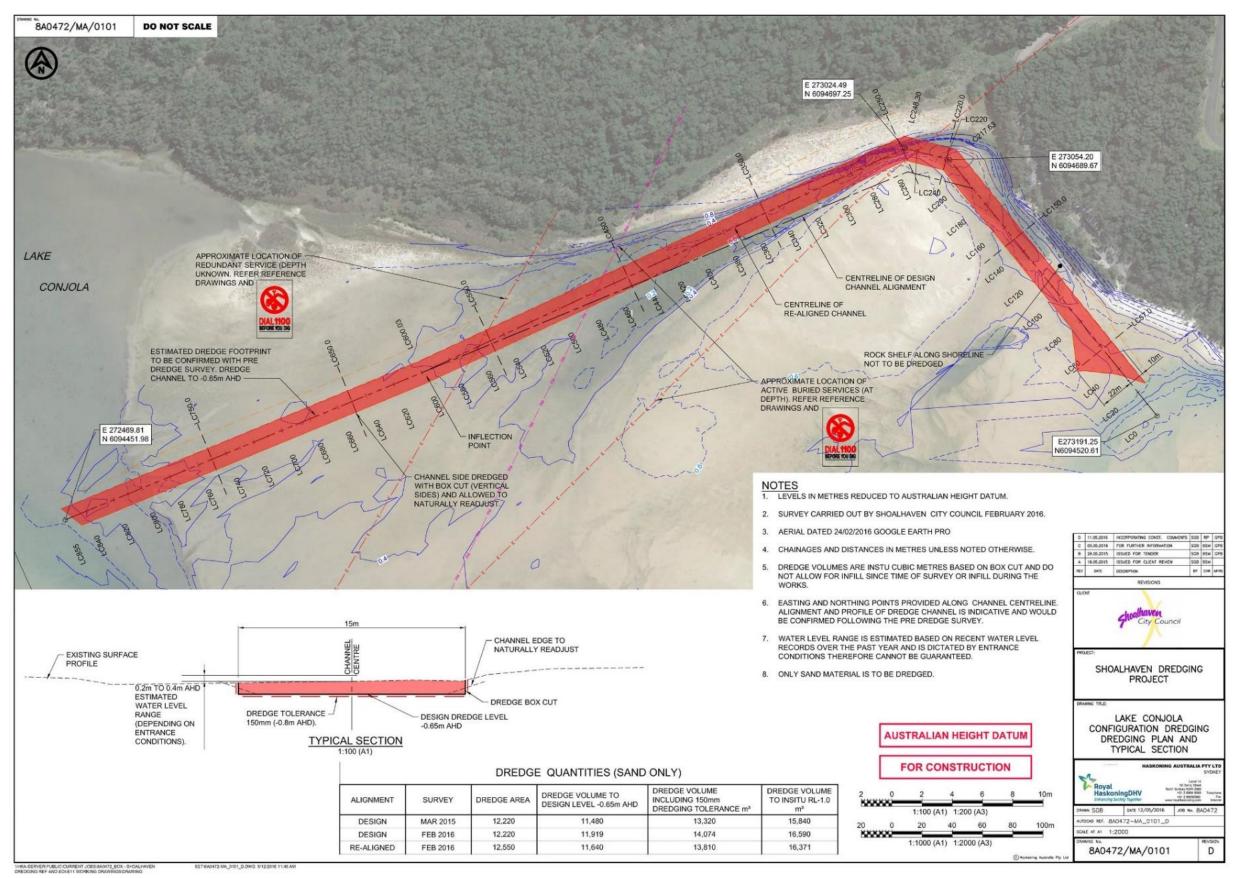
Figure 4-20: Dredging plan and typical section for navigation access dredging in 2016

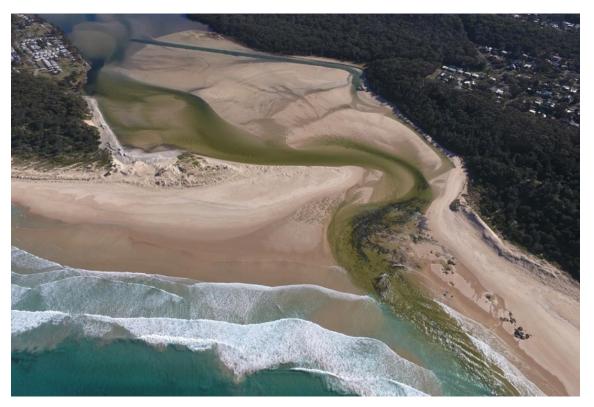
Figure 4-21 and Figure 4-22 show images of the dredging in 2016.

Figure 4-21: View looking westwards over the entrance area showing the dredged channel in the background and natural channel in the foreground (CCB, 2017)

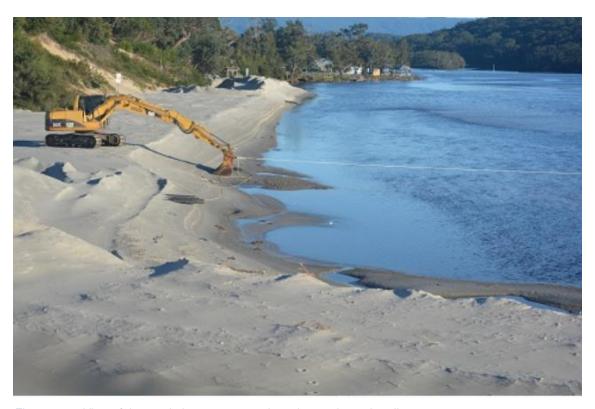
Figure 4-22: View of the sand placement area along the southern shoreline
