Lake Conjola Coastal Management Program Stage 2 Determine Risks, Vulnerabilities and **Opportunities**

Report C - "Entrance Processes and Entrance Management Options"

Shoalhaven City Council

Reference: PA2591-SCC-CMP-Stage 2 Report C-0003

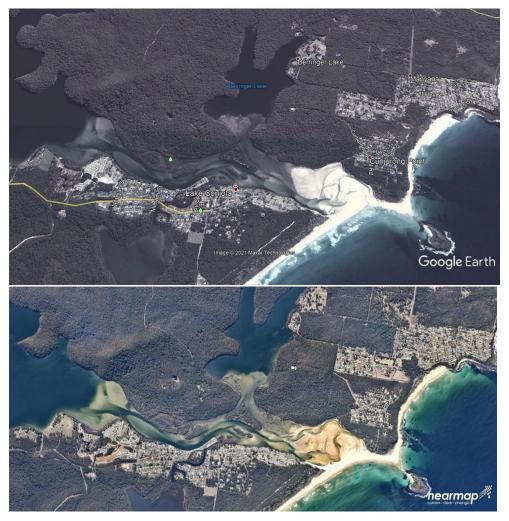
The approach is a modification of the 'managed entrance' option considered in Patterson Britton (1999); the difference being that in that option the aim was to keep the entrance permanently open (the imperative at that time) whereas in the modified managed entrance approach it is accepted the aim is just to try and keep the entrance open for longer on average and avoid loss of the ebb tide channel which would necessitate a much longer pilot channel (impacting adversely on the timing of a response and effectiveness of a mechanical breakout, hence flood risk). A loss of a distinct ebb tide channel due to storm washover deposits followed by build up of the surface level of the deposits under wind action has occurred in the past as indicated in **Figure 5-1**; and,

Figure 5-1: Loss of distinct ebb tide channel due to storm washover – September 2011 (top) and September 2018 (bottom)

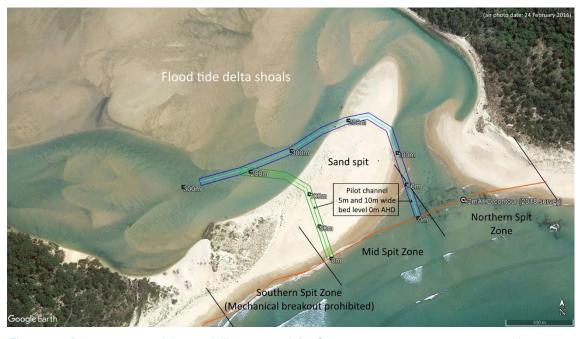
**Figure 5-2** shows the proposed positions for modelling of the pilot channels in the mid spit zone and in the northern spit zone. The northern extent of the pilot channel in the northern spit zone corresponds to the location of exposed bedrock in the seabed profile. It is considered unlikely the pilot channel would be excavated further to the north.

The lengths of the pilot channels are annotated commencing from a 2m AHD contour along the beach determined from a 2018 survey when the entrance was closed. The air photo included in **Figure 5-2** as a base is dated 24 February 2016 and depicts an open entrance in a Regime state (refer **Section 2.5.2**). The air photo is included for context and scale only.

Figure 5-2: Diagram summarising modelling approach for Category 1 entrance management options

**Figure 5-3** shows the proposed position for modelling of the pilot channel and notch, located in the northern spit zone only (same position as northern pilot channel in **Figure 5-2**). In this case, for illustration, the base for the figure is the bathymetry (bed level) file in the numerical model. The bed level is colour coded relative to AHD.

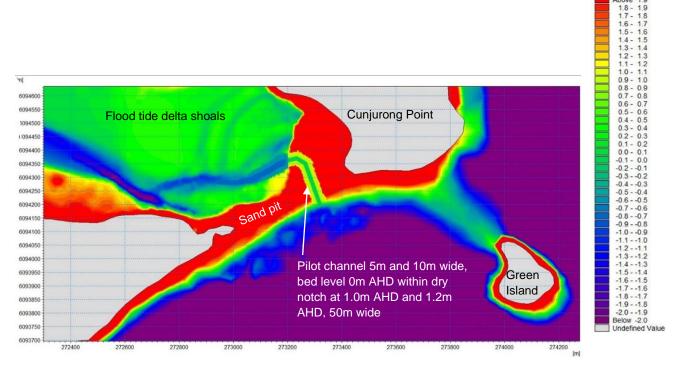
Figure 5-3: Diagram summarising modelling approach for Category 2 entrance management options

From a modelling perspective, the only significant difference between the Category 2 and Category 1 options is the elevation level of the berm in Category 2 (1.0 and 1.2m AHD) versus Category 1 (2.0m AHD).

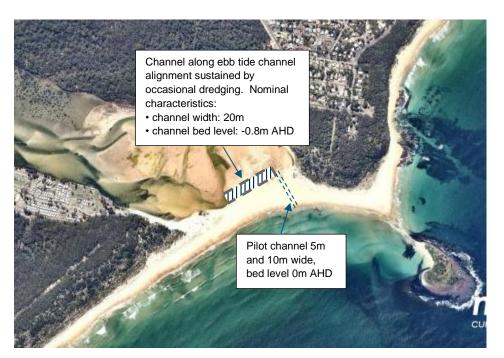
**Figure 5-4** shows the proposed modelling approach for the Category 3 entrance management options superimposed on the 14 September 2018 aerial photo corresponding to a time when a distinct ebb tide channel did not exist due to storm washover deposits.

Figure 5-4: Diagram summarising modelling approach for Category 3 entrance management options (Air photo date 14 September 2018)

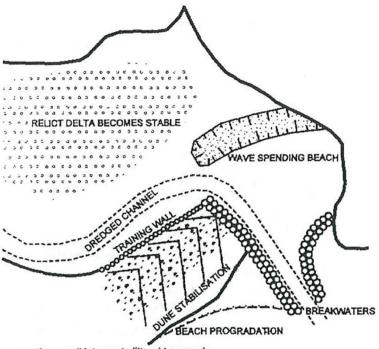
The conceptual arrangement of the twin entrance breakwaters is shown in Figure 5-5.

- southern wall intercepts littoral transport
- twin walls to reduce wave penetration
- entrance spit built-up to eliminate closure by storm washover
- channel dimensions maintained as per past flood scour

Figure 5-5: Conceptual arrangement of twin entrance breakwaters adopted to demonstrate a permanent entrance channel

It is noted that this permanent entrance concept is on a lesser scale than the permanent entrance opening adopted in BMT WBM (2013a) as a possible flood mitigation option. In that study an entrance channel width of 125m and entrance bed level of -4m AHD was adopted.

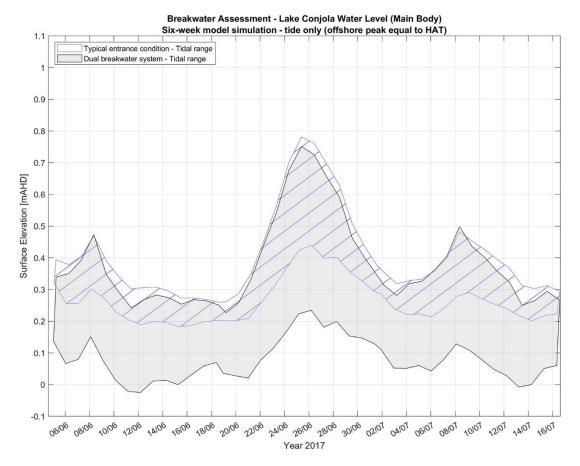
It is evident from Figure 5-6 that the effect of a permanent channel would be as follows:

Figure 5-6: Modelled effect of a permanent entrance channel on lake water level

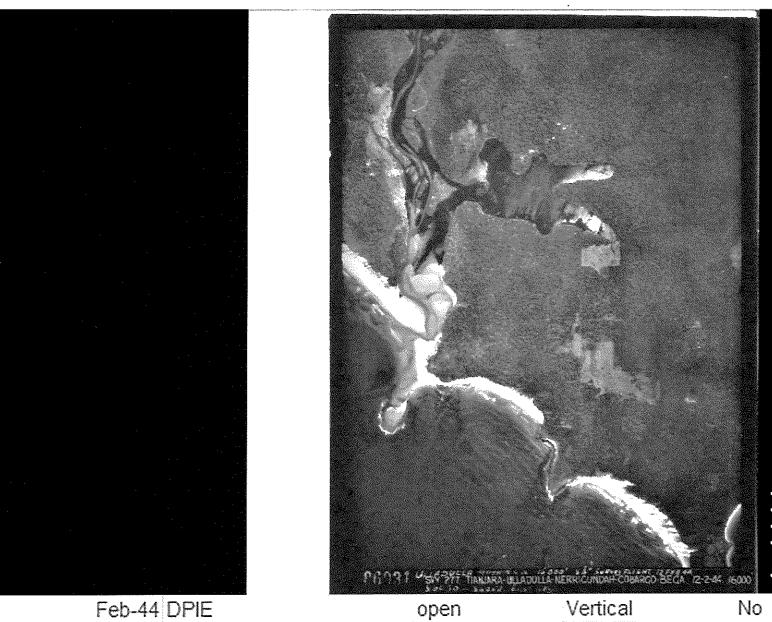
- Entrance condition = Intermediate/regime
  1944 was the driest year on record
  No major storms for 18 months
  Entrance stayed open, slowly migrating to the north
- Relatively small active flood tidal delta

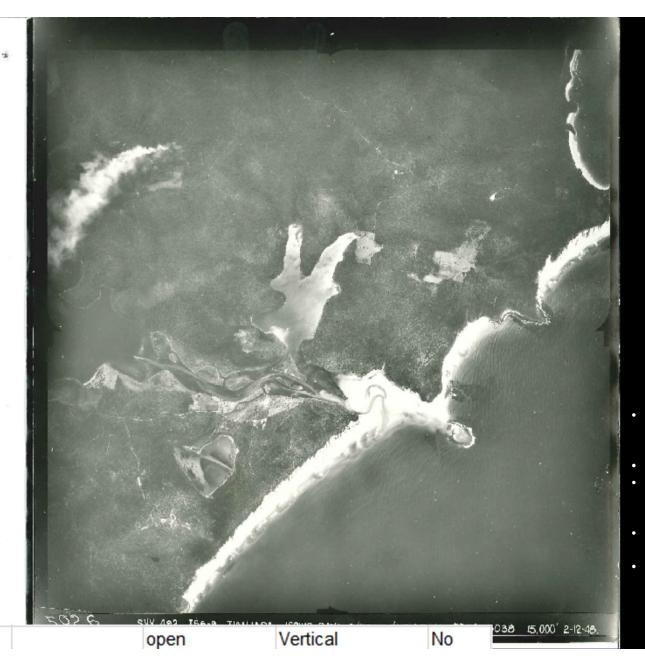
Dec-48 DPIE

- Entrance condition =
   Washover/heavily shoaled –
   entrance almost closed
- Three major storms in 1948
- Substantial storm washover emanated from N to S through tombolo
- December storm almost closed entrance
- Significant accretion along Cunjurong Beach due to storm wave action

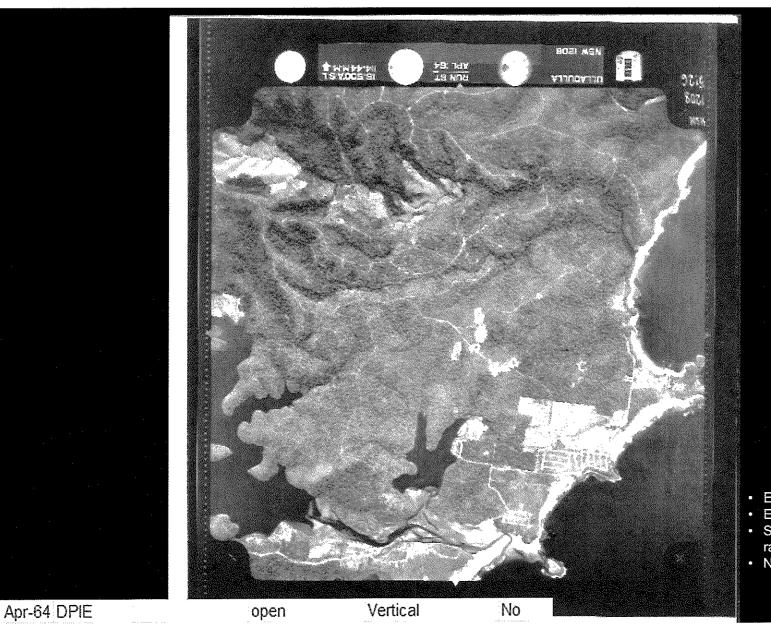
- Entrance condition = Regime state
  Entrance up against northern side
  Slightly flood scoured after > 300mm rainfall in April
  No major storms

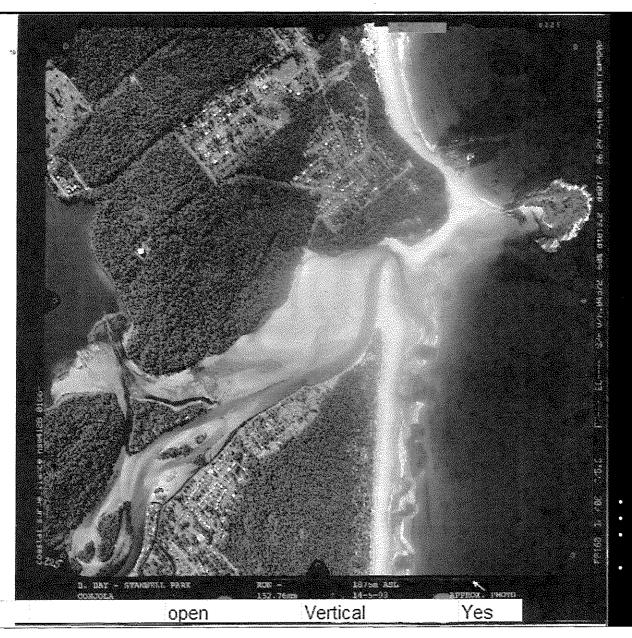
May-93 DPIE

- Entrance condition = Regime state
  Internal tidal scour against high dune
  Regular freshes throughout 1992 and 1993 have kept entrance open
  No major storms

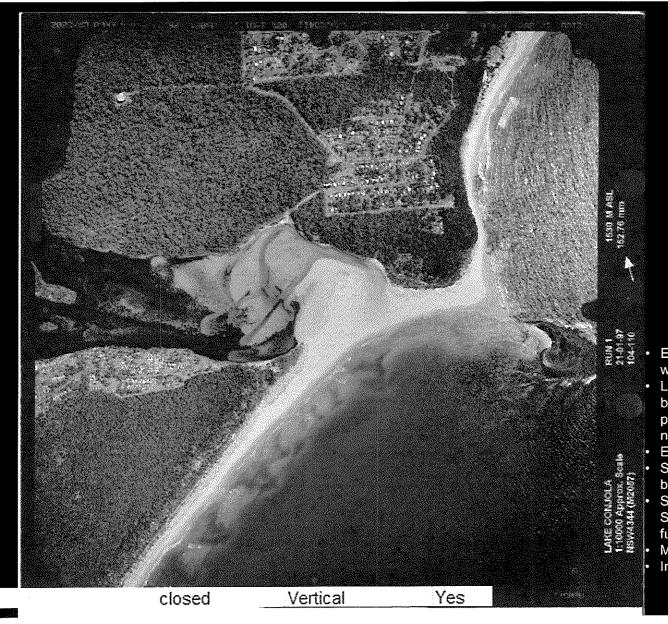
Jan-97 DPIE

- Entrance condition = Closed/Storm washover
- Large washover by March 94 storm blocked main channel and forced perched tidal channel around northern perimeter
- Entrance closed towards end of 94
- Since closure, wind blown sand building up entrance spit
- Severe storms in September 95 and September & November 96 added further washover deposits
- Minor freshes only
- Internal channels heavily shoaled

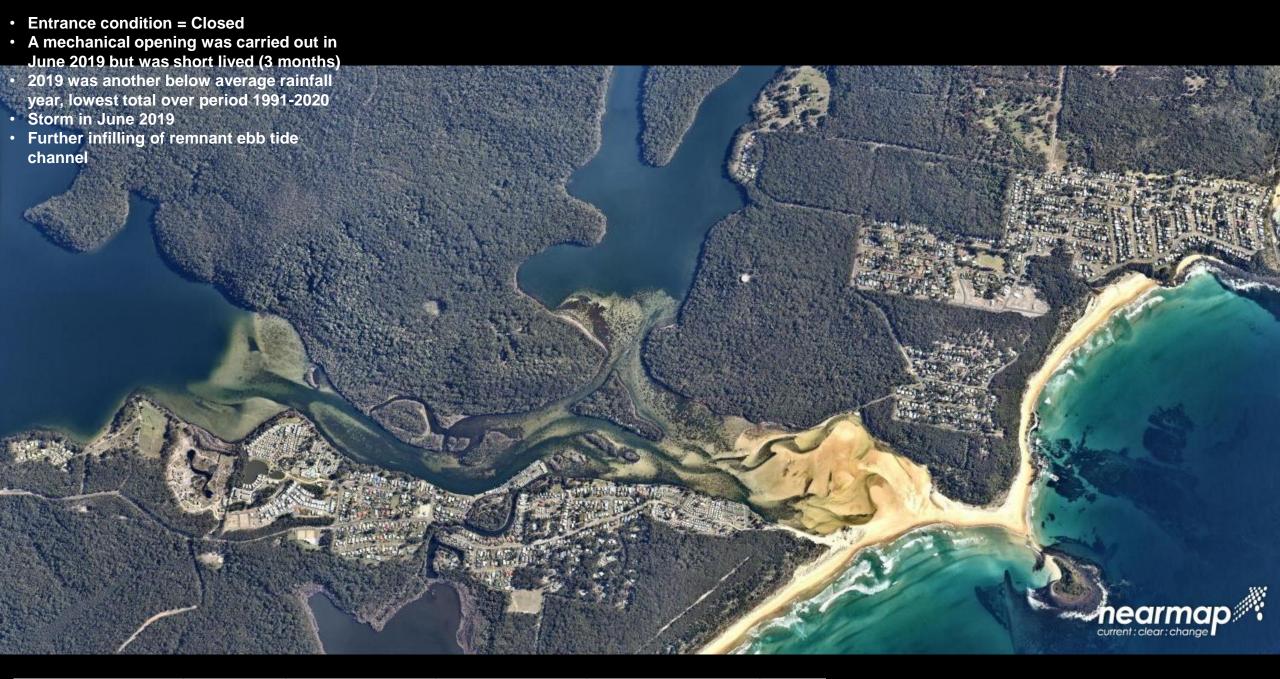
14/9/2019 nearmap closed Vertical Yes

• Entrance condition = Closed

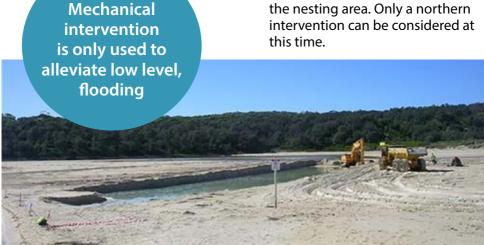
A central to northern location is favoured because

- Green Island protects the northern area from wave energy and storm wash-over
- littoral drift causes the spit to move northwards, naturally forcing the entrance channel towards Cunjurong Point
- with a channel located along a rocky shoreline, such as Cunjurong Point, there are benefits to both scouring and persistence of the opening
- threatened migratory shorebirds nest on the sand spit at Lake Conjola and are endangered.
   During the nesting season from September to March, Council must minimise disturbance to the nesting area. Only a northern intervention can be considered at this time
