***MANAGEMENT STRATEGY***

***SOUTHERN FORESHORE RESERVE***

***NARRAWALLEE BEACH***

**Based on a proposed strategy prepared by Southern Regen for Shoalhaven City Council**

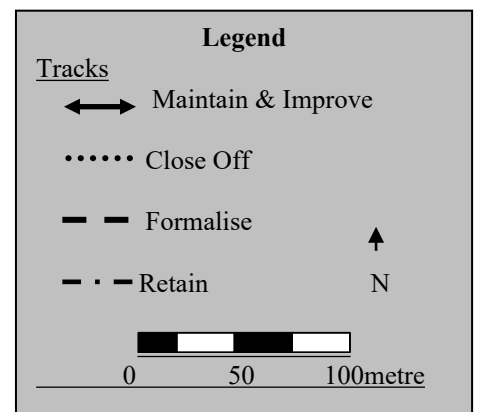
**Map 4: Management Zones and Access Track Works required, Southern Foreshore Reserve, Narrawallee Beach**

- 1. These management zones have been identified using existing physical boundaries, accessibility and current and future management strategies (see map 4).**
- 2. Bushcare projects and programs will be developed within Zones 1 to 5 inclusive and Parkcare projects and programs will be developed within Zones 6 and 7.**
- 3. All activities undertaken by the Bushcare and Parkcare Groups are to be in accordance with the written agreement between Council and each group.**
- 4. Weed control in all Zones is to be undertaken using best practice control techniques as per the NSW National Trust Bush Regenerators Handbook.**

- Zone 1** Continue bush regeneration and weed control for environmental and noxious weed species. Work outward from good areas of bushland (see map 3).  
Strengthen and maintain the definition of the boundary between the bushland and the parkland as outlined under 'Maintenance' on Page 12 of this document.  
Close off unnecessary beach access track and restore vegetation (see map 4).

- Close off unnecessary tracks (see map 4);
- Monitor and enforce penalties for clearing of native vegetation;
- Continue bush regeneration/weed control for environmental and noxious weed species;
