Bomaderry Floodplain Risk
Management Study and Plan

FIGURES

Bomaderry Creek FRMSP

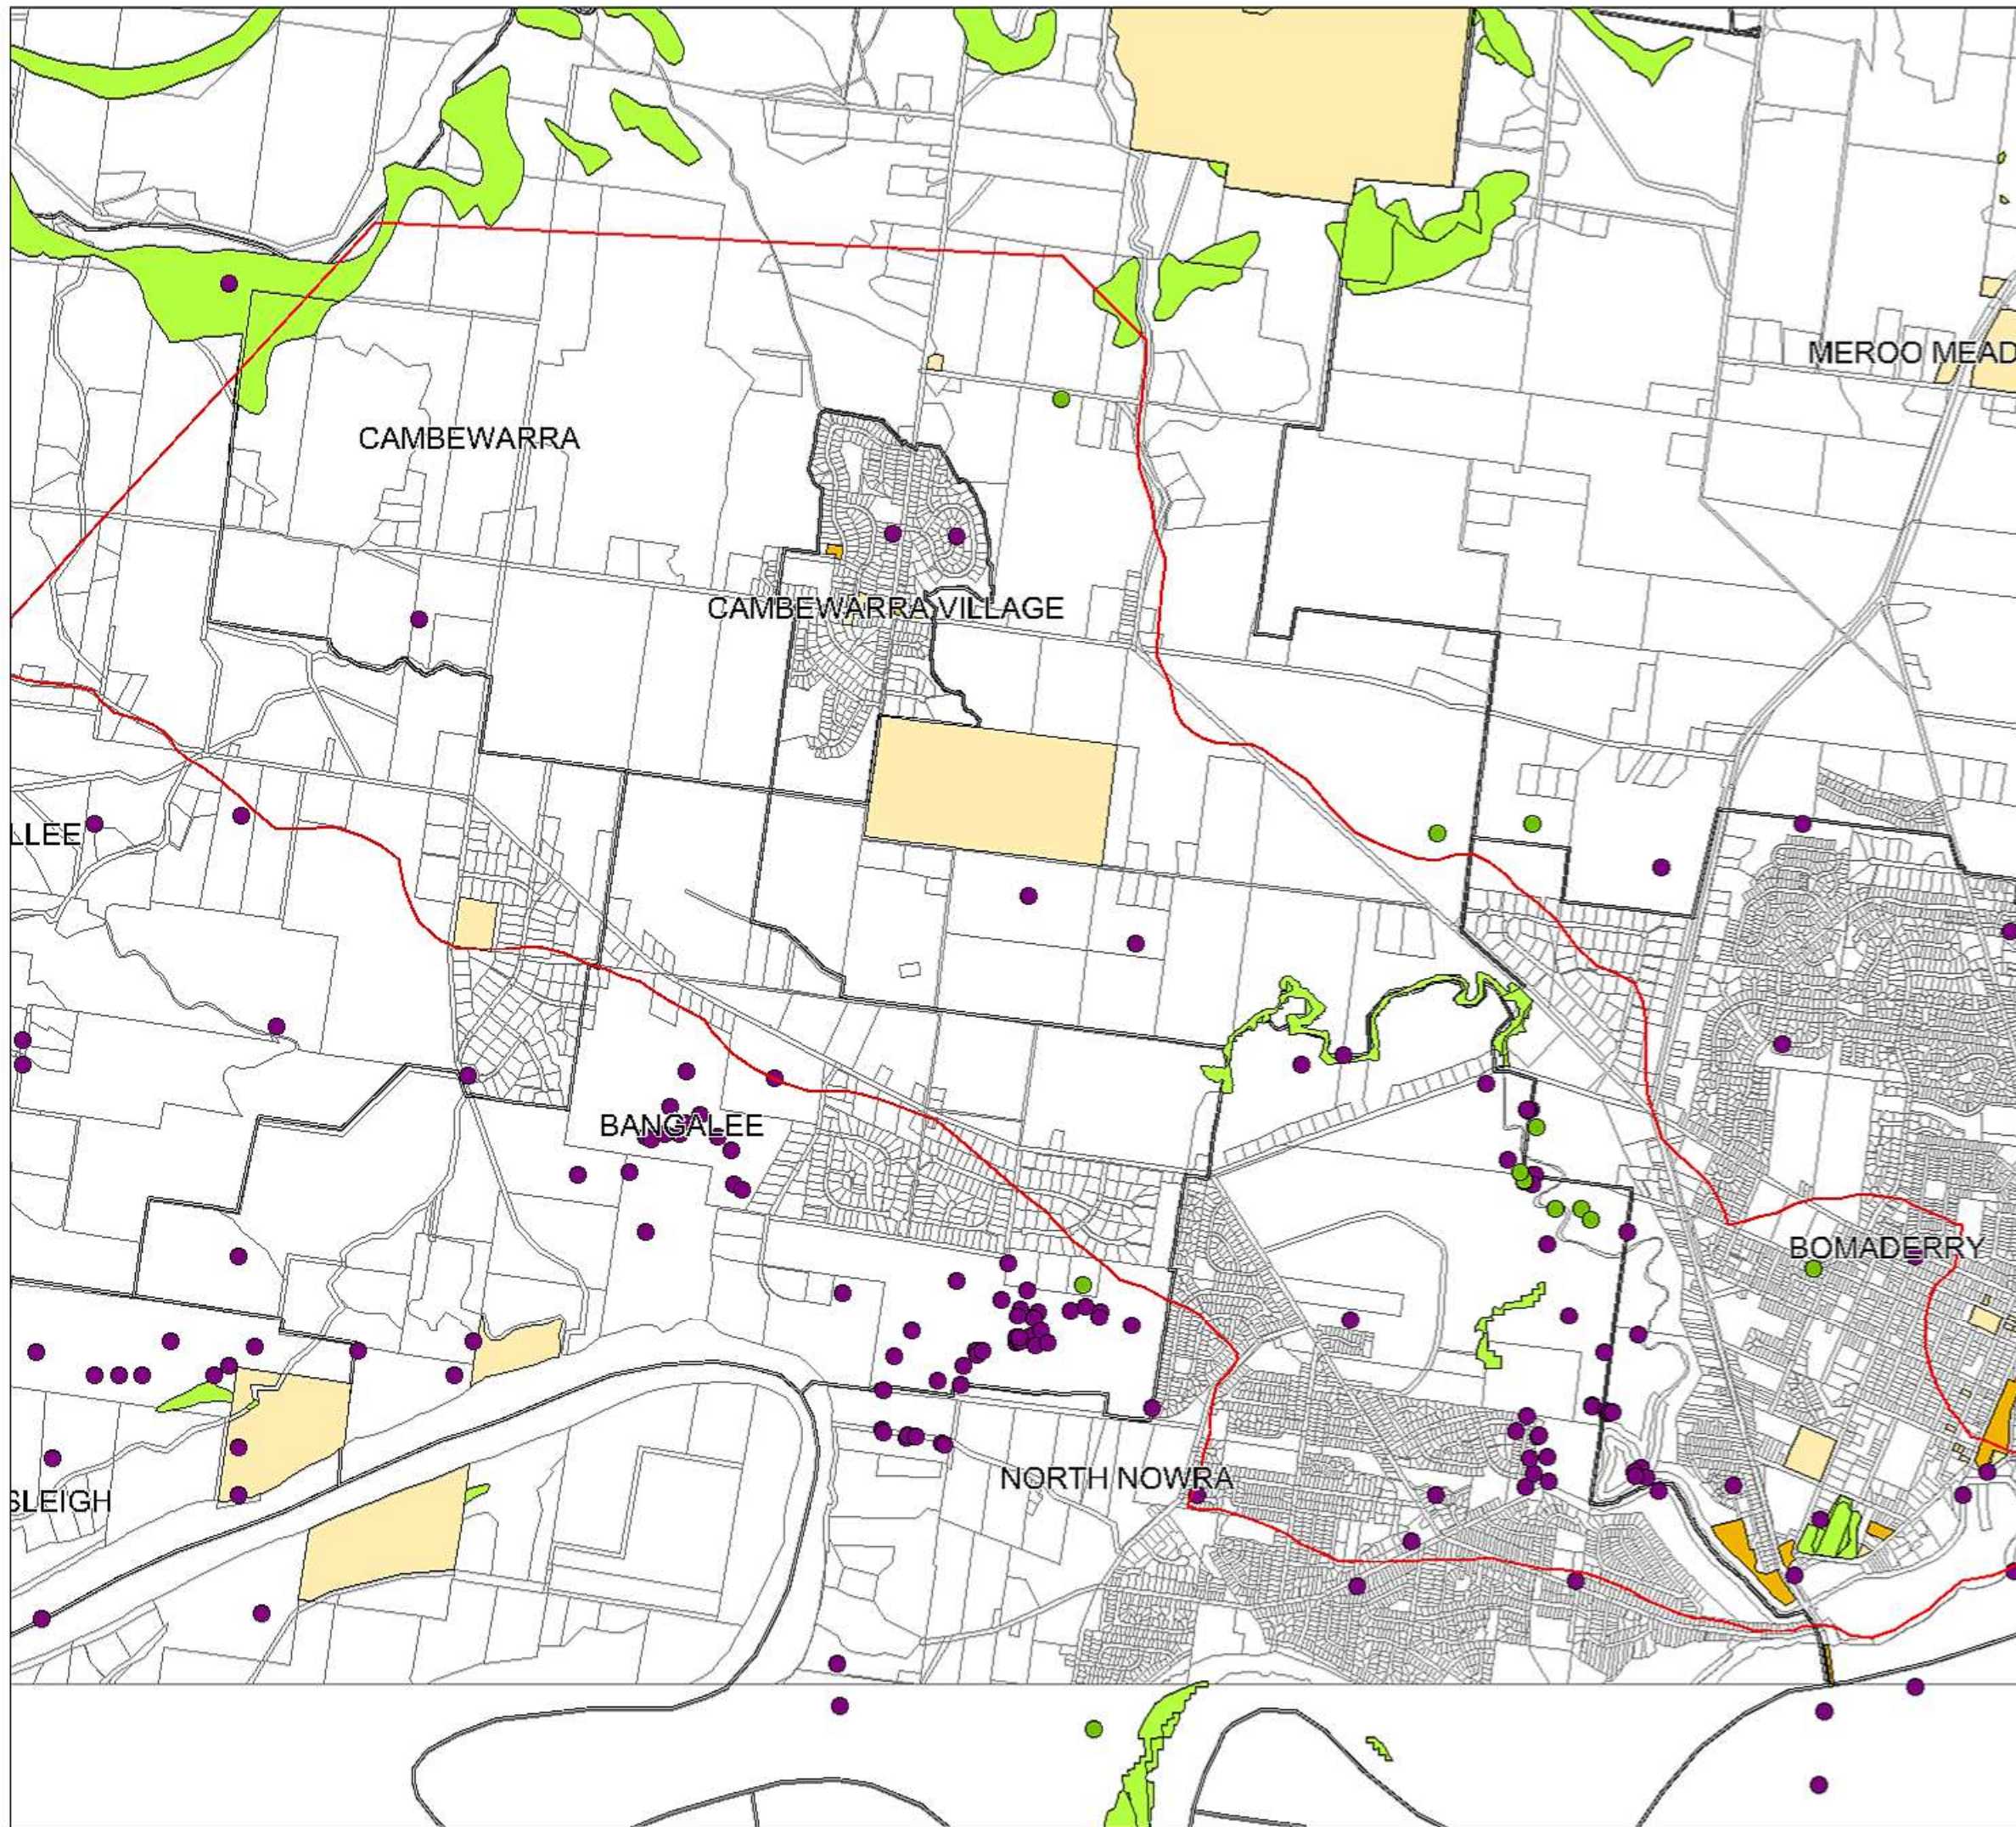
Figure 8-1

Environmental Features
