The Frontline News

Coastal Management in Shoalhaven

ISSUE 5 • AUGUST 2016 Catch up on previous editions [here](#)

THE BIGGEST WAVE ON RECORD!

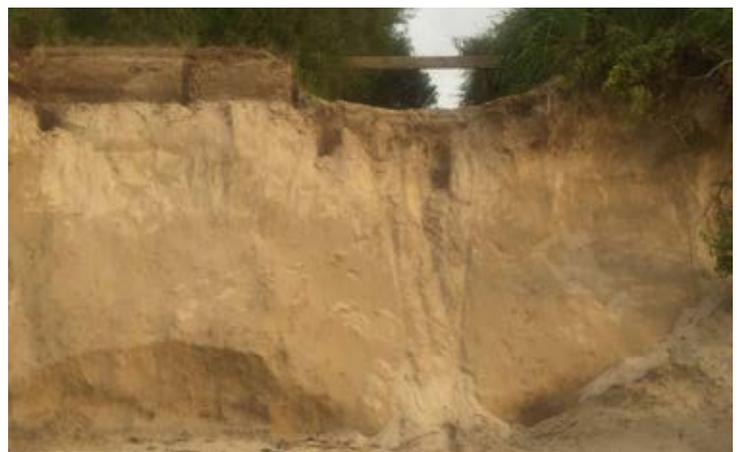
- Approximately 20,000 cubic metres of sand was lost from the beach with the dune face receding 6-8 m, leaving a 3-4 metre high sand cliff
- 6 beach access ways were destroyed. Because the dune face at Currarong Beach was steep, accesses were constructed steps and stairs.
- One staircase costs approximately \$25,000, so not all six can be replaced.

One of the staircases destroyed at Currarong.

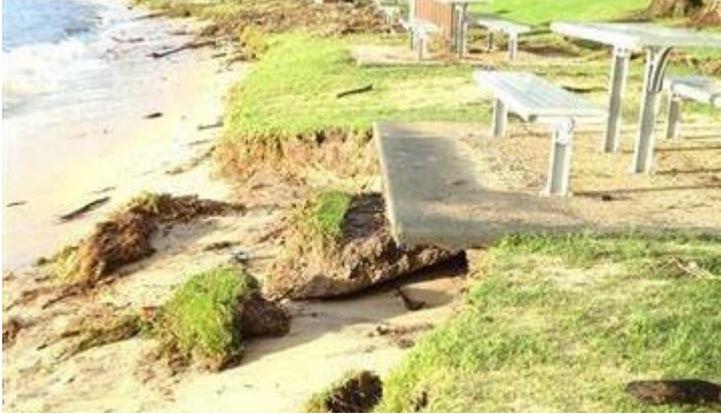
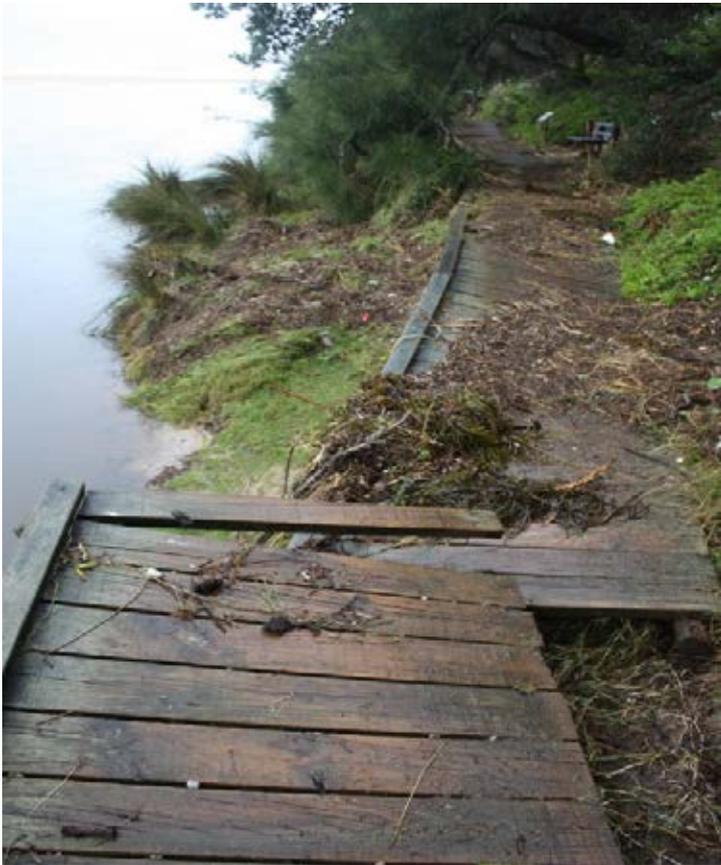
Ulladulla Harbour

Imprints in the sand—all that was left of a viewing platform and staircase at the eastern end of Currarong Beach.

The beach was eroded and a picnic table had to be removed. The rock wall that protects the footpath and highway has been damaged.

It's hoped that the RMS will contribute to shoreline protection work.

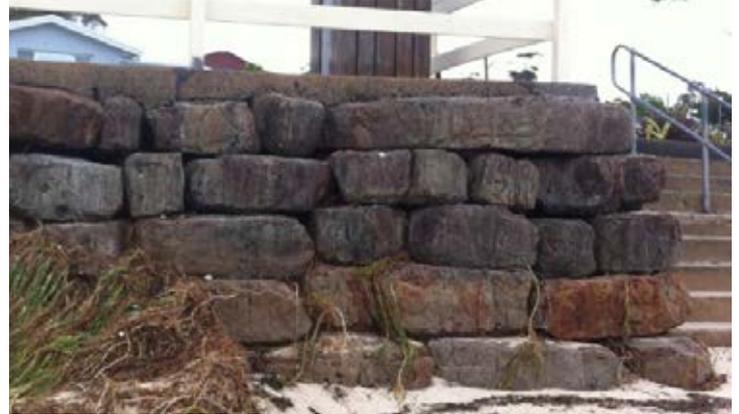
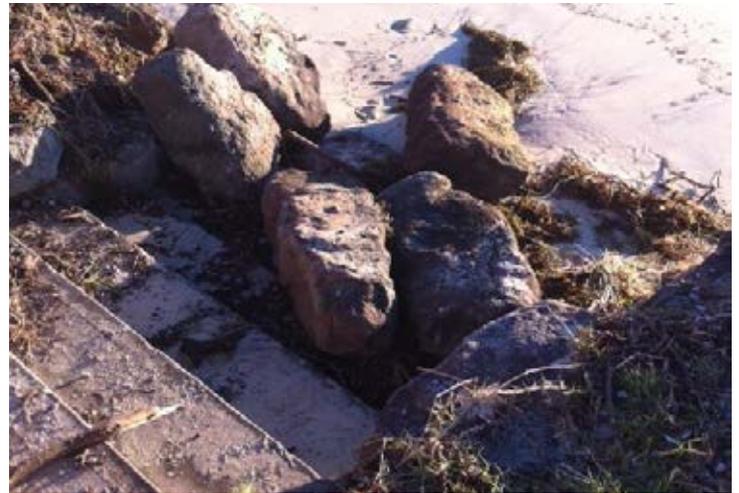
Prior to the June ECL, council had been seeking advice from coastal engineering consultants regarding shoreline protection assets at South Mollymook. The gabion rock wall protects the Golf Club, major sewer infrastructure and a walkway. The adjacent sandstone sea wall protects the road and walkway. Both assets are approaching the end of their useful life - which the ECL shortened further. Preliminary designs and costings indicate that replacing and upgrading shoreline protection in this precinct, (Golf Club through to the Surf Club) may approach \$3.5million.

Voids in the sea wall have opened further (above) and a corner section collapsed (below) during the ECL.

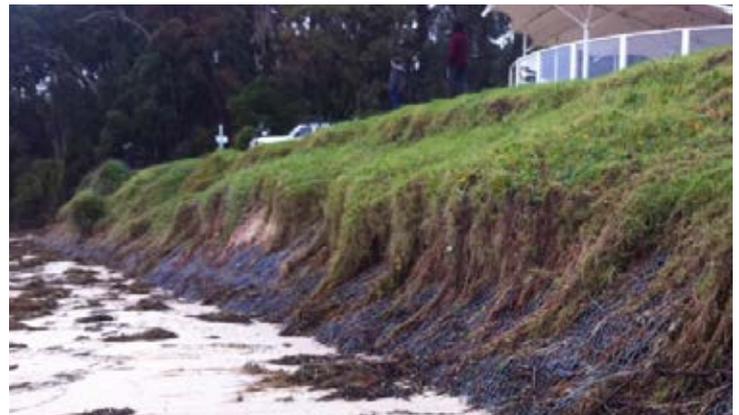
Each time the gabions are exposed, further damage is done.

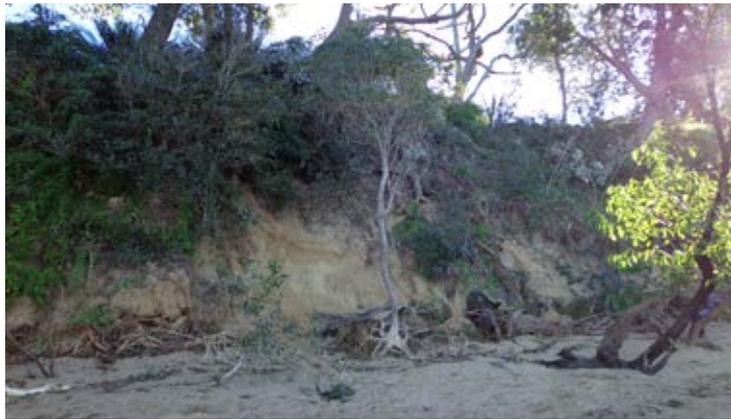
Shoalhaven Heads

The entrance of the Shoalhaven River opened naturally at the 'dry notch' (low point in the dune) maintained by Council. As a result during the ECL, ocean swell with the high tide entered the estuary. This, combined with river flooding, caused erosion along the River Road foreshore where four access points were damaged.

The beach also experienced significant storm bite and beach access points were damaged.

Council has completed tree management works to make the area safe and is seeking coastal engineering advice regarding longer term management options.

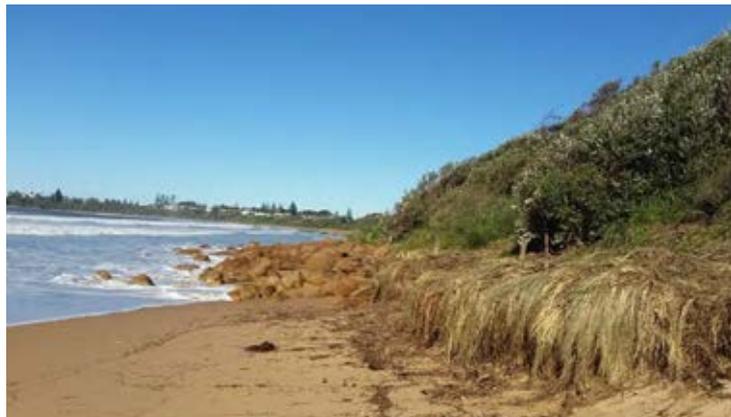
Culburra Beach

Beach access ways were damaged along the entire beach with some rock outcrops uncovered.

Short term works to repair beach access ways are underway and longer term works will be assessed.

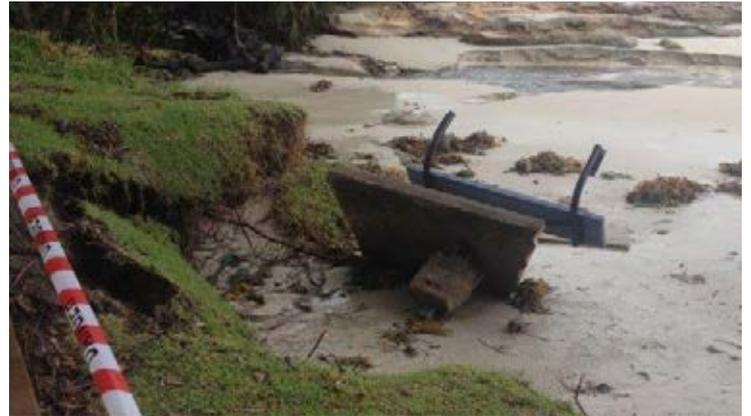
Vincentia

Storm water outlets at Collingwood Beach were eroded and sections of the shared pathway suffered damage.

Repairs to the path and relocation of picnic tables and seats is required.

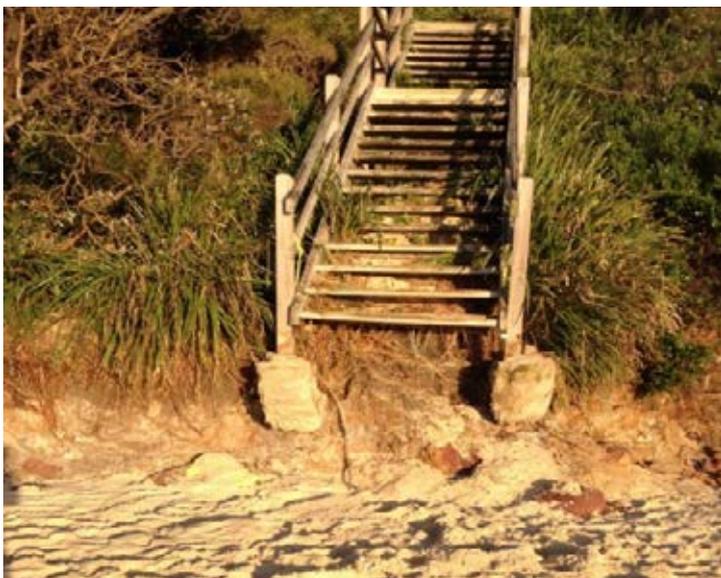
- The access ways are a mix of sand tracks, back filled steps, constructed staircases, boardwalks and concrete ramps (examples shown). All require ongoing maintenance (including regular vegetation pruning) to keep them safe and useable.

- Many of the assets (boardwalks, staircases etc), having been constructed in the 80s and 90s, are now approaching the end of their useful lives; so although they may not have been damaged in this last ECL, they are still in need of major repair or replacement.
