Coastal Management in Shoalhaven

Shoalhaven
City Council

ISSUE 5 • AUGUST 2016 Catch up on previous editions [here](#)

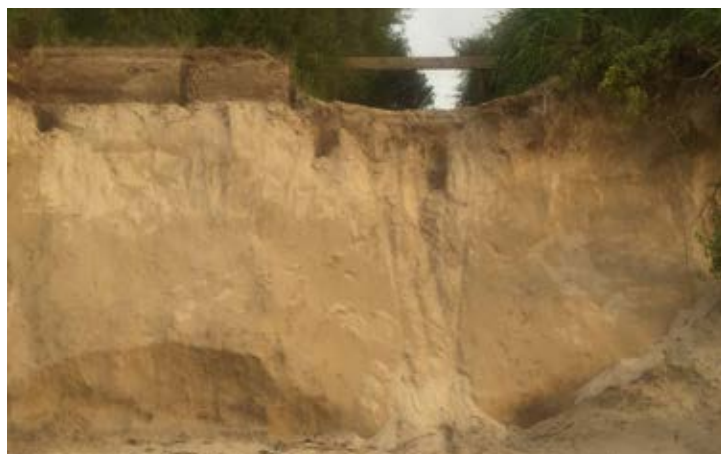
- Approximately 20,000 cubic metres of sand was lost from the beach with the dune face receding 6-8 m, leaving a 3-4 metre high sand cliff
- 6 beach access ways were destroyed. Because the dune face at Currarong Beach was steep, accesses were constructed steps and stairs.
- One staircase costs approximately \$25,000, so not all six can be replaced.

One of the staircases destroyed at Currarong.

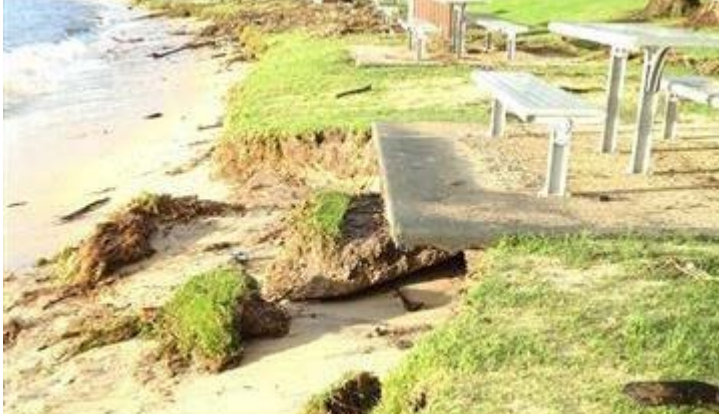
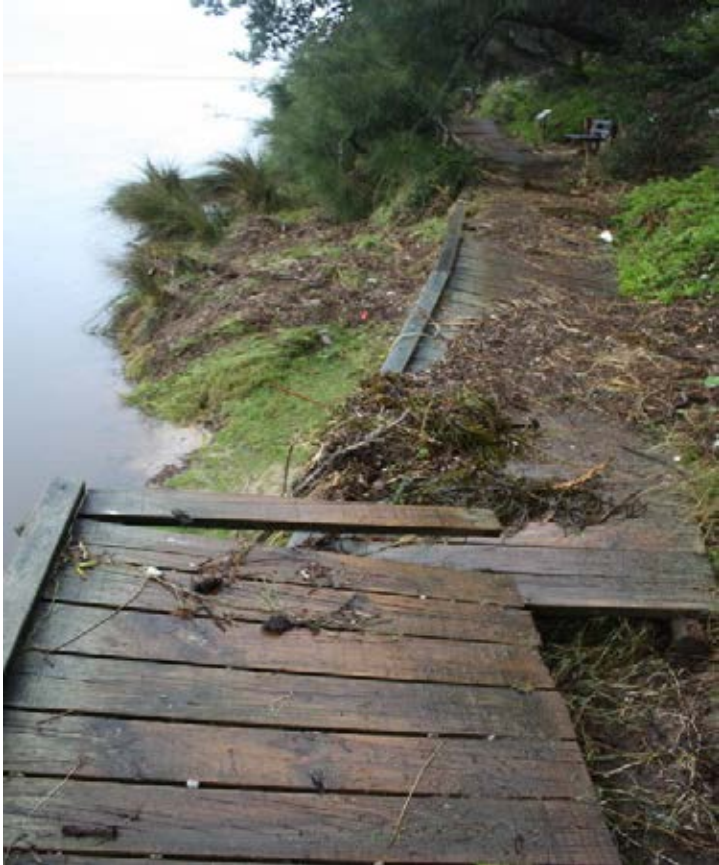
Ulladulla Harbour

The beach was eroded and a picnic table had to be removed. The rock wall that protects the footpath and highway has been damaged.

It's hoped that the RMS will contribute to shoreline protection work.

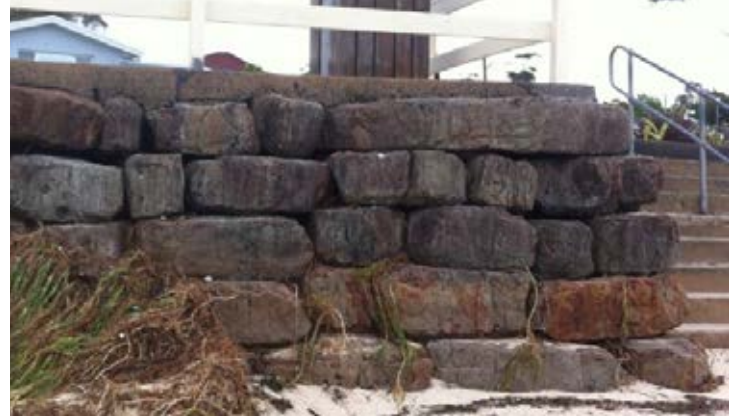
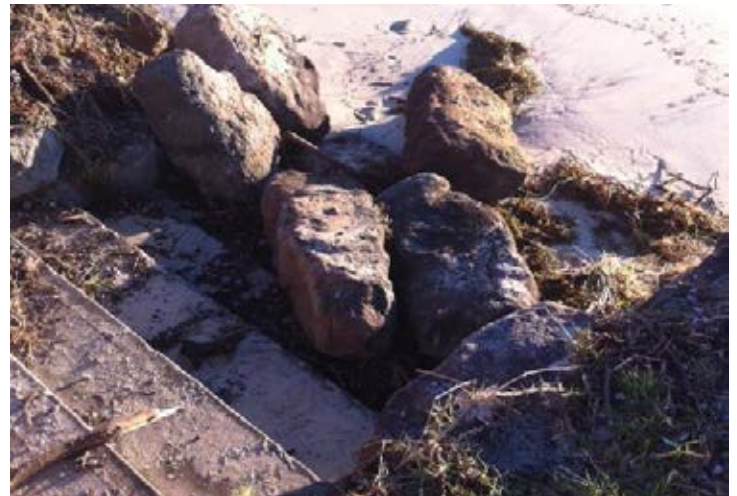
Prior to the June ECL, council had been seeking advice from coastal engineering consultants regarding shoreline protection assets at South Mollymook. The gabion rock wall protects the Golf Club, major sewer infrastructure and a walkway. The adjacent sandstone sea wall protects the road and walkway. Both assets are approaching the end of their useful life - which the ECL shortened further. Preliminary designs and costings indicate that replacing and upgrading shoreline protection in this precinct, (Golf Club through to the Surf Club) may approach \$3.5million.

Voids in the sea wall have opened further (above) and a corner section collapsed (below) during the ECL.

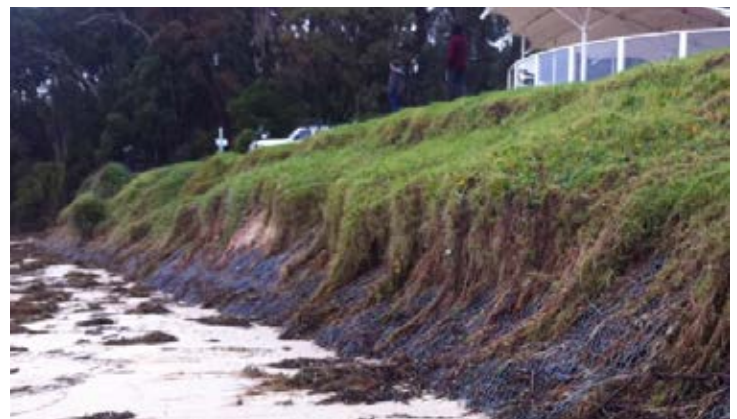
Each time the gabions are exposed, further damage is done.

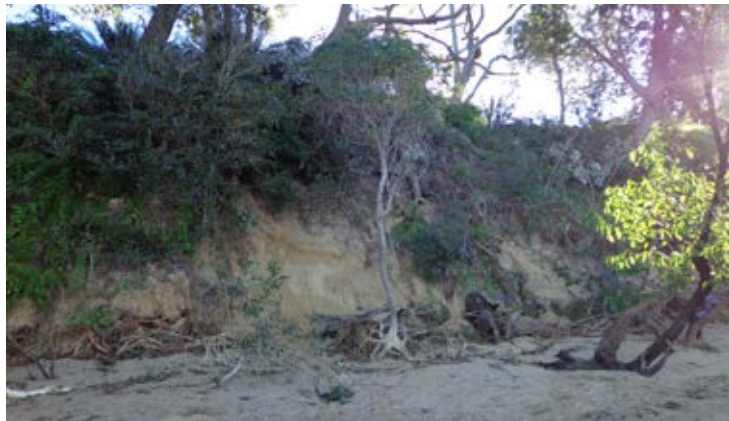
Shoalhaven Heads

The entrance of the Shoalhaven River opened naturally at the 'dry notch' (low point in the dune) maintained by Council. As a result during the ECL, ocean swell with the high tide entered the estuary. This, combined with river flooding, caused erosion along the River Road foreshore where four access points were damaged.

The beach also experienced significant storm bite and beach access points were damaged.

Council has completed tree management works to make the area safe and is seeking coastal engineering advice regarding longer term management options.

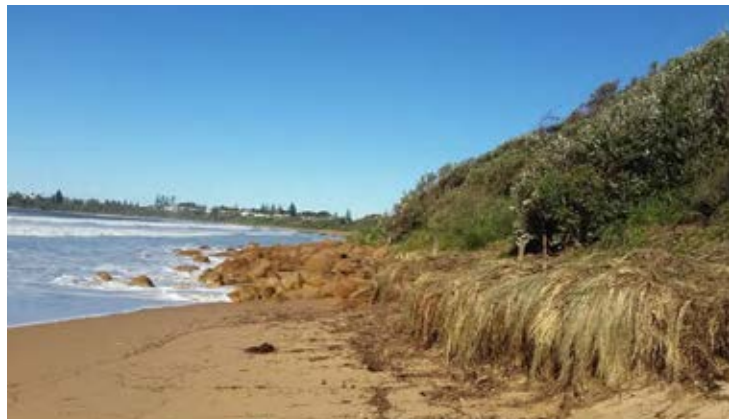
Culburra Beach

Beach access ways were damaged along the entire beach with some rock outcrops uncovered.

Short term works to repair beach access ways are underway and longer term works will be assessed.

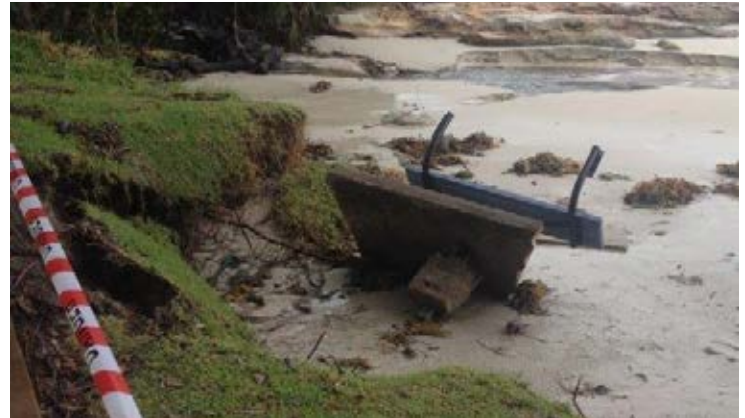
Vincentia

Storm water outlets at Collingwood Beach were eroded and sections of the shared pathway suffered damage.

Repairs to the path and relocation of picnic tables and seats is required.

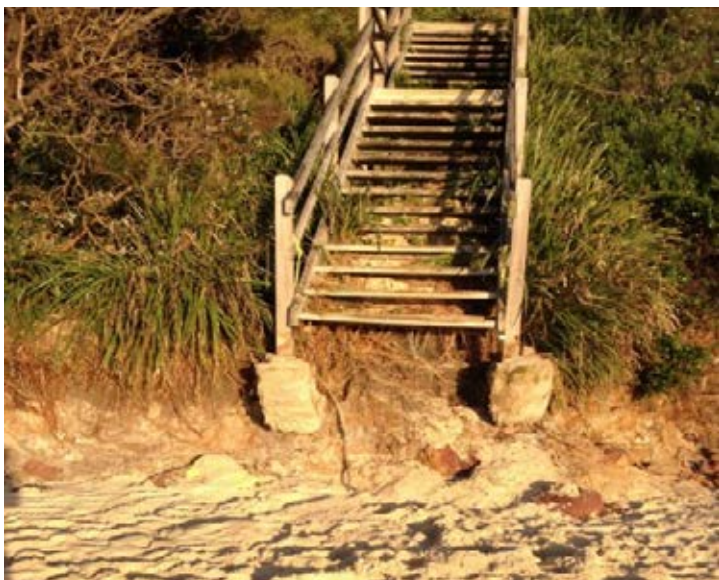
- The access ways are a mix of sand tracks, back filled steps, constructed staircases, boardwalks and concrete ramps (examples shown). All require ongoing maintenance (including regular vegetation pruning) to keep them safe and useable.

- Many of the assets (boardwalks, staircases etc), having been constructed in the 80s and 90s, are now approaching the end of their useful lives; so although they may not have been damaged in this last ECL, they are still in need of major repair or replacement.
